# **Assessment of Impact on the Maritime Usage Report – Volume 3**

## **Navigation Maintenance Dredging 2026-2033**

On behalf of  
**Port of Waterford**

**Volume 3:   Appendix F: Benthic Assessment of Disposal Site**

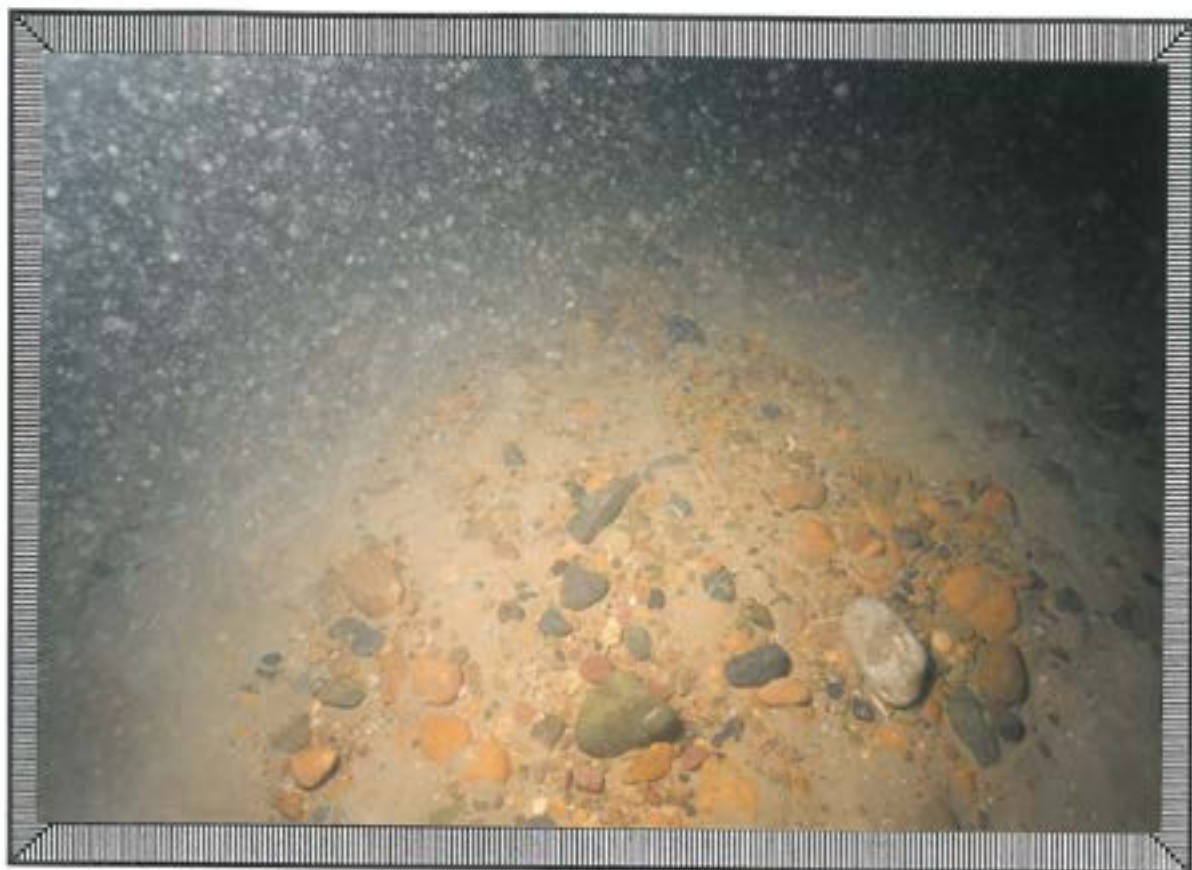
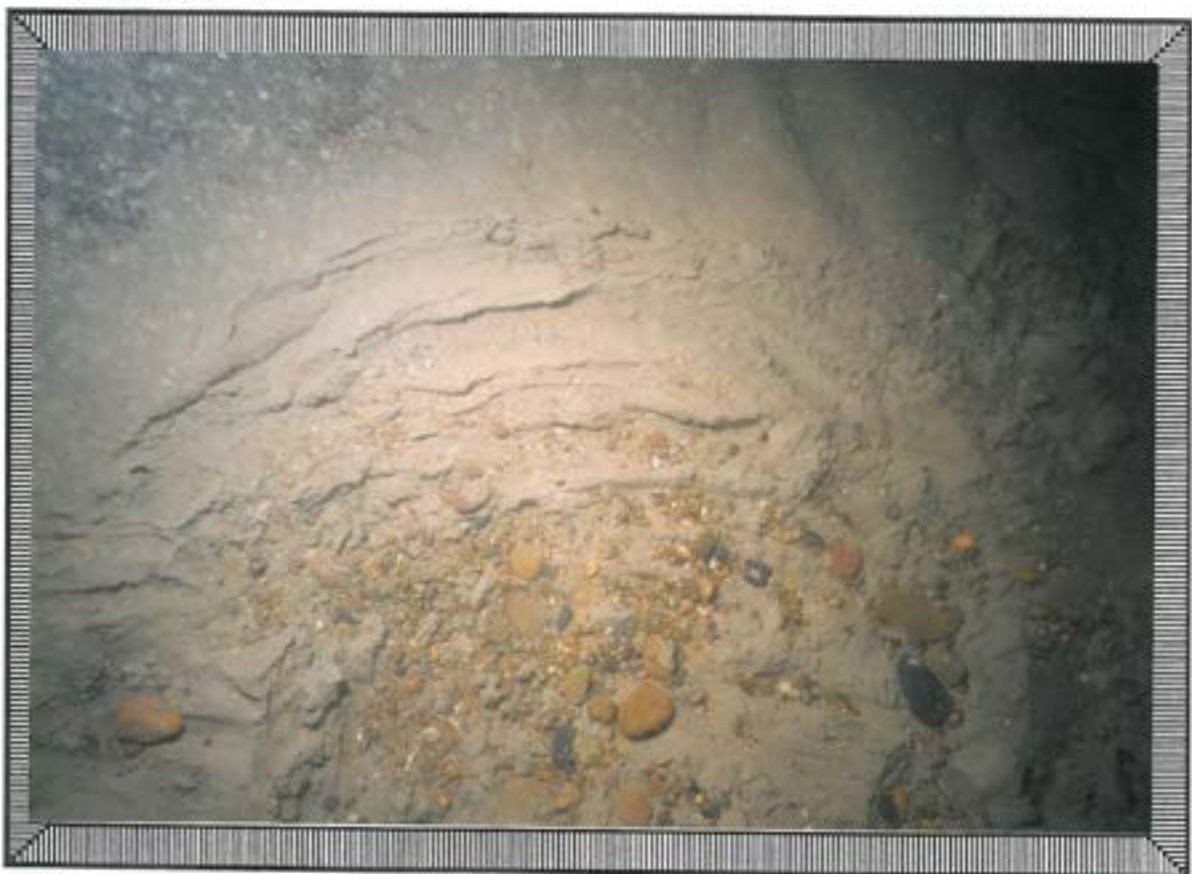
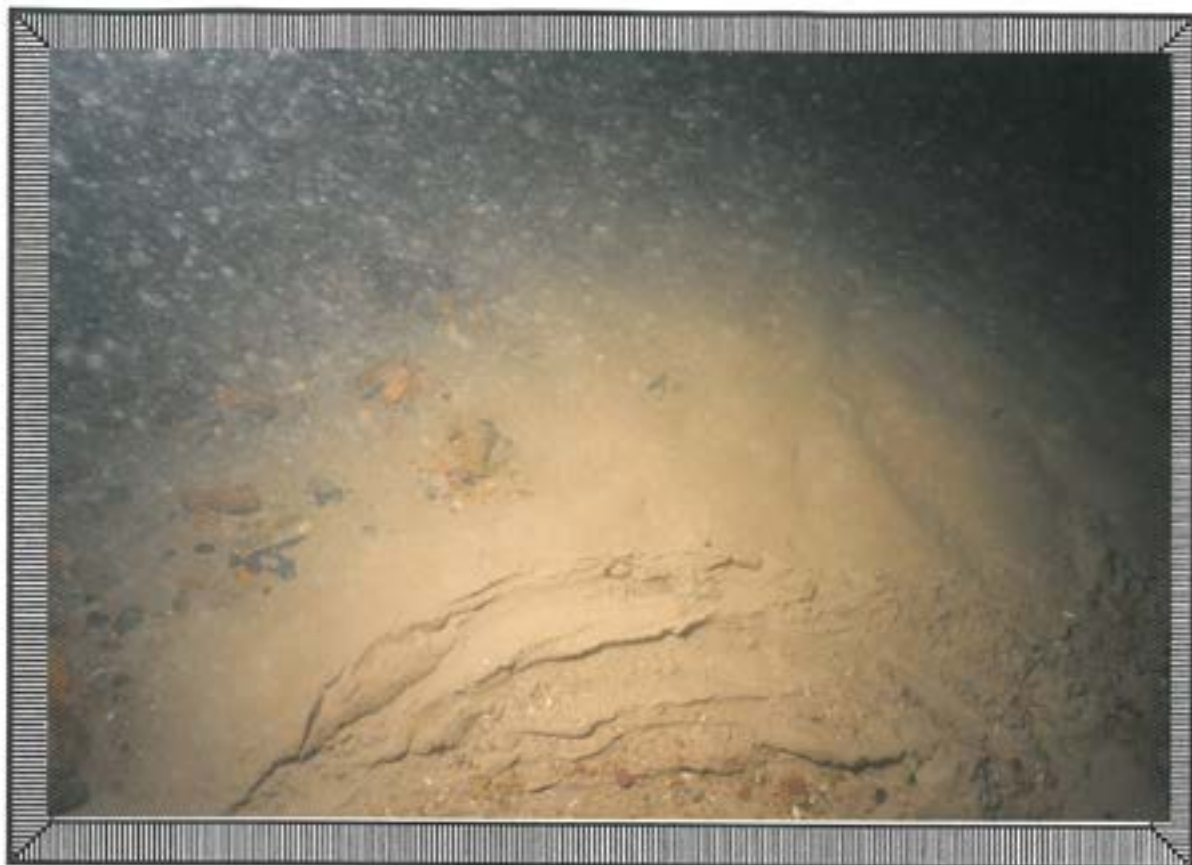
Bottom conditions prevailing to the extreme north of the dumpsite are seen in photo's 19-22. There was a extremely light, flocculent layer of fine material covering a

coarse gravel bottom. This fine material was easily displaced and in places was moving with the bottom current. No fauna were observed.

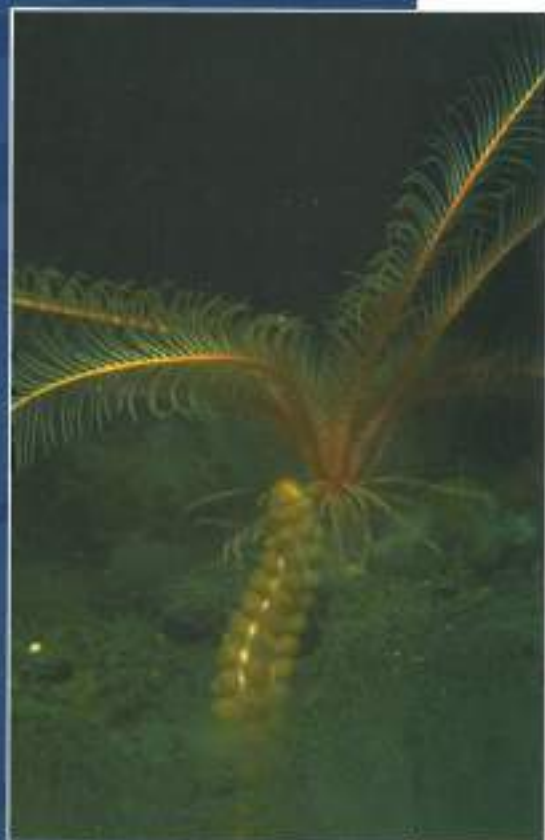
SPI image taken at 1,500m, off the Aleutian Islands USA, showing a leather star and starfish arm.

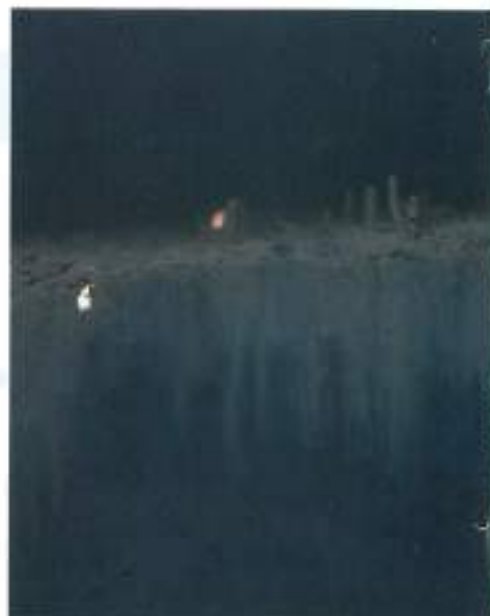
SPI image taken in the Firth of Clyde, Scotland showing tube worms and a highly variable redox discontinuity.

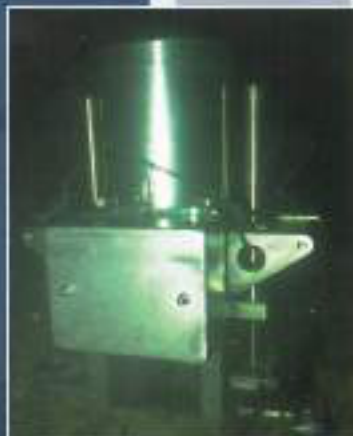
Diver operated SPI being used to monitor organic enrichment on fish farms in Norway

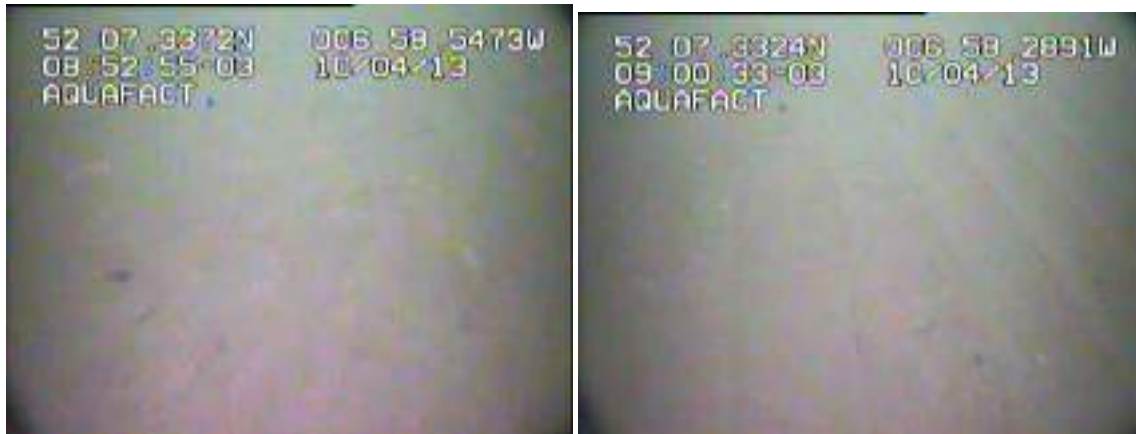
Figure 2.6: Snapshot of the sedimentary environment in the spoil ground.

Table 2.5 shows the sediment characteristics of the faunal stations. Station S15 contained the highest percentage of gravel (5.1%), very coarse sand (5.8%) and coarse sand (8.1%). Station S11 had the highest percentage of medium sand (7.6%). Station S16 had the highest percentage of fine sand (20.7%). Station DS1 had the highest percentage of very fine sand (76.5%) and station S3 had the highest percentage of silt-clay (46.4%). The sediment sampled from the area was classified according to Folk (1954) as sand in the spoil ground and outer harbour area and varied between muddy sand, slightly gravelly muddy sand and gravelly muddy sand in the inner harbour area. The substrata type at all stations can be seen graphically in Figure 2.5 below. Figure 2.6 shows two snapshots of the sedimentary environment in the spoil ground. Organic matter values ranged from 0.81 (S16) to 10.6 (S11).

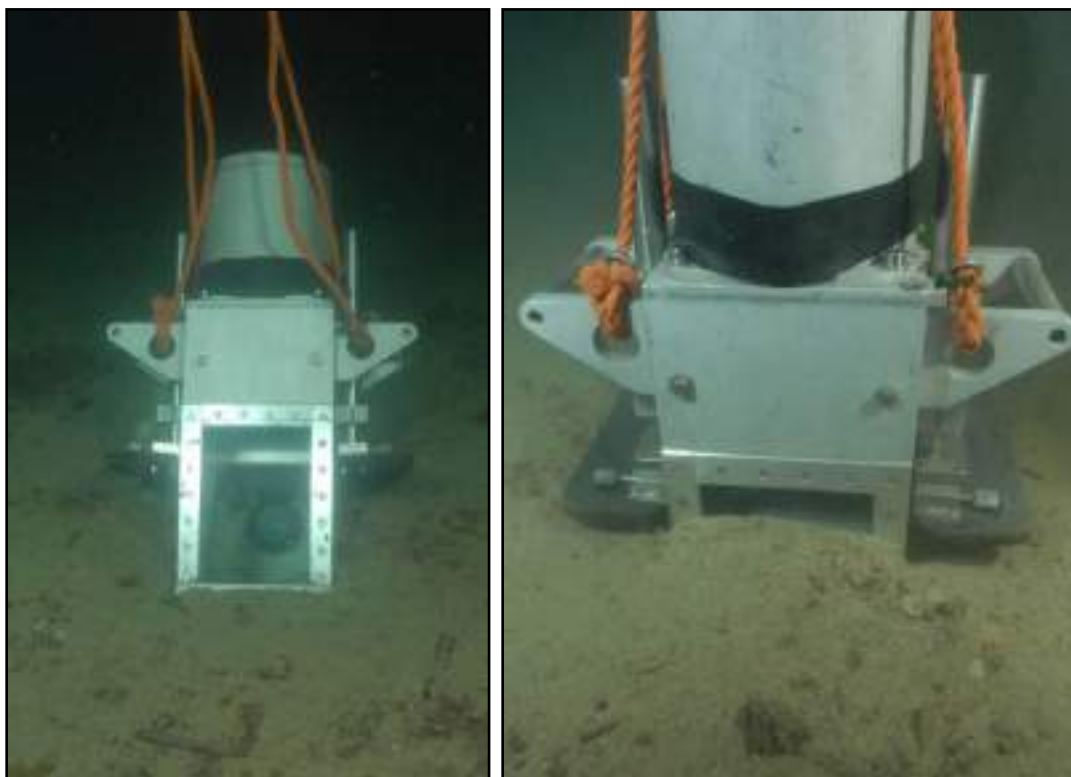
**Figure 2-2: Diver operated Sediment Profile Imaging camera. The left-hand image gives a view of the camera at the sediment surface. The right-hand image shows the SPI camera when inserted into the sediment.**

SPI is particularly useful in the analysis of disposal sites. The extent and dispersion patterns of material can be quickly assessed and recovery rates of the bottom visually estimated. Dredge spoil material is normally of a different texture/grain size to a disposal sites natural sea floor and a visual record can be made of the layering of this material over the bottom.

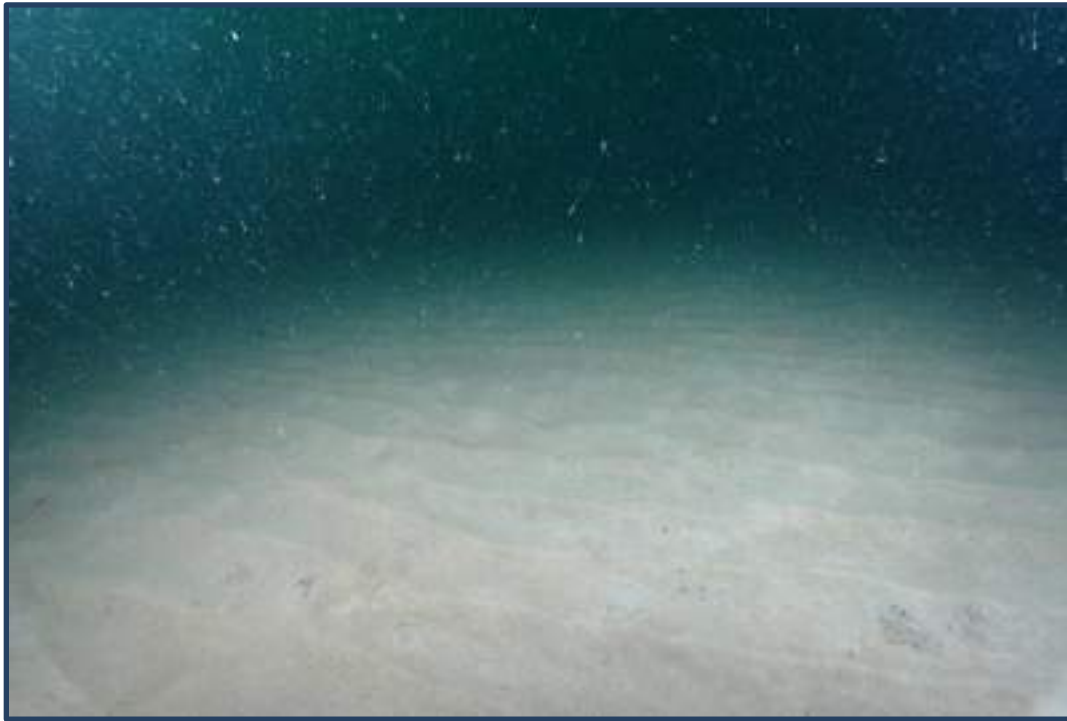
**Plate 3-2 Station 2, Waterford Disposal site, 10<sup>th</sup> September 2020**

The seafloor at station 2 consisted of fine sand that was formed into small waves by the action of tidal currents (Plate 3-2). Apart from a small hermit crab (*Pagurus bernhardus*) there was little else of note on the surface (Plate 3-3).

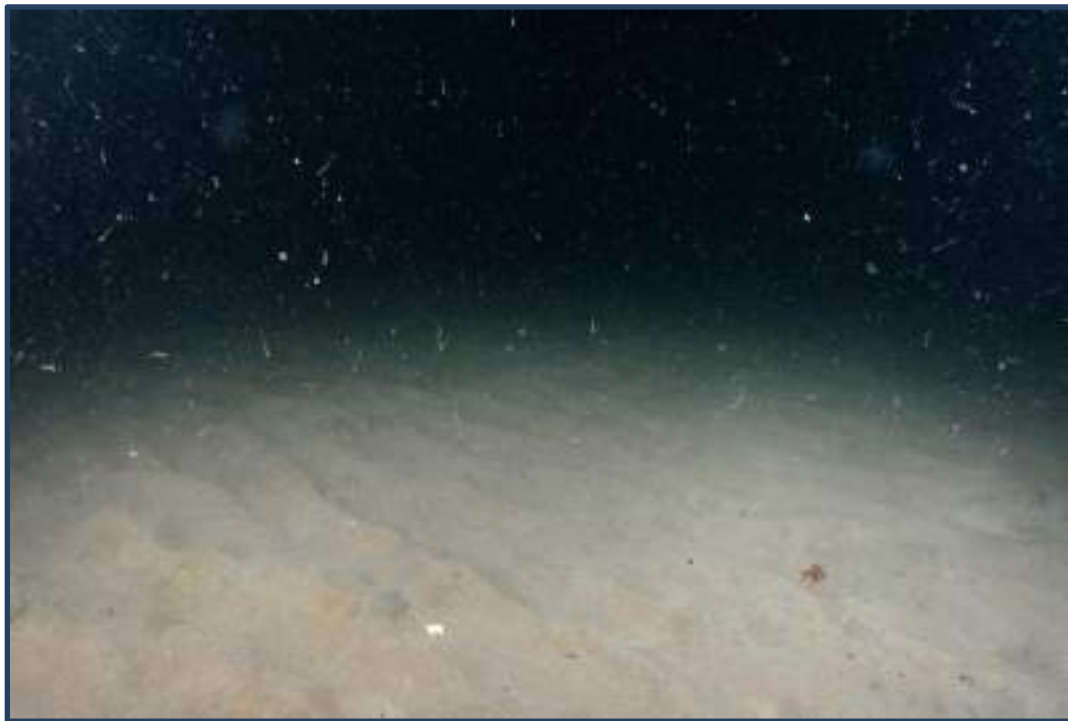
**Plate 3-6 Station 4, Waterford Disposal site, 10<sup>th</sup> September 2020**

The seafloor at Station 4 consisted of fine sand formed into small waves (Plate 3-6). Apart from some broken shell and small particles of drift algae, there were no other features of note on the seafloor.

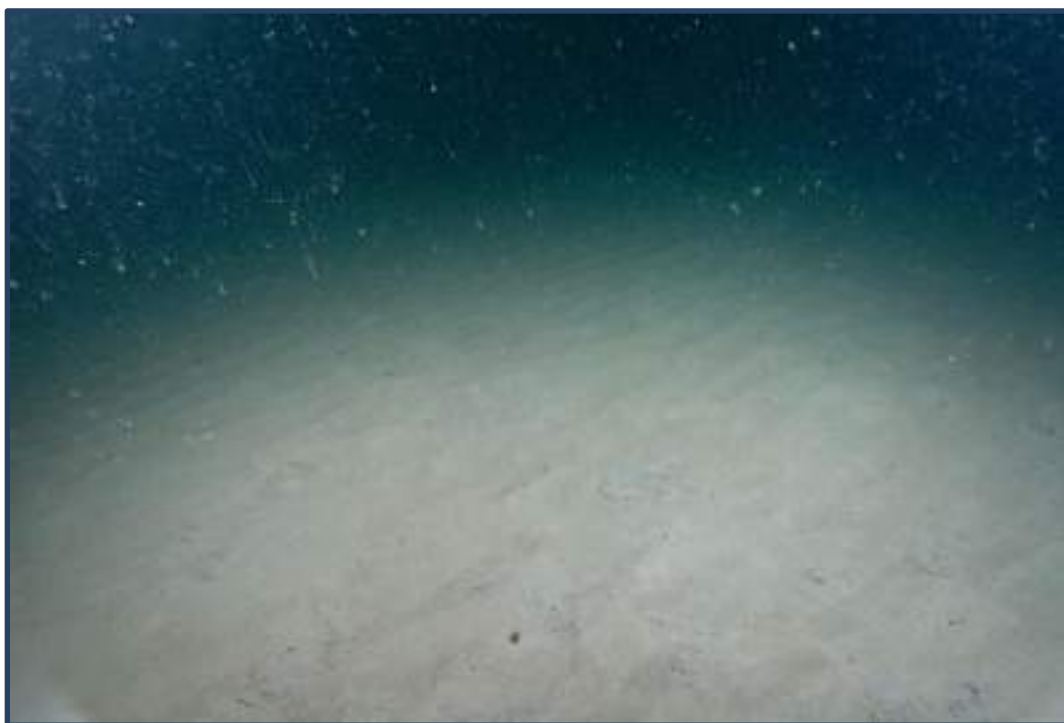
**Plate 3-7 Station 5, Waterford Disposal site, 10<sup>th</sup> September 2020**

Station 5 was located in the centre of the disposal site. As for the other stations, the seafloor consisted of fine clean sand formed into small waves by the action of tidal currents (Plate 3-7). A small hermit crab (*P. bernhardus*) and plaice (*P. platessa*) were imaged on the sediment surface along with small particles of drift algae (Plate 3-8).

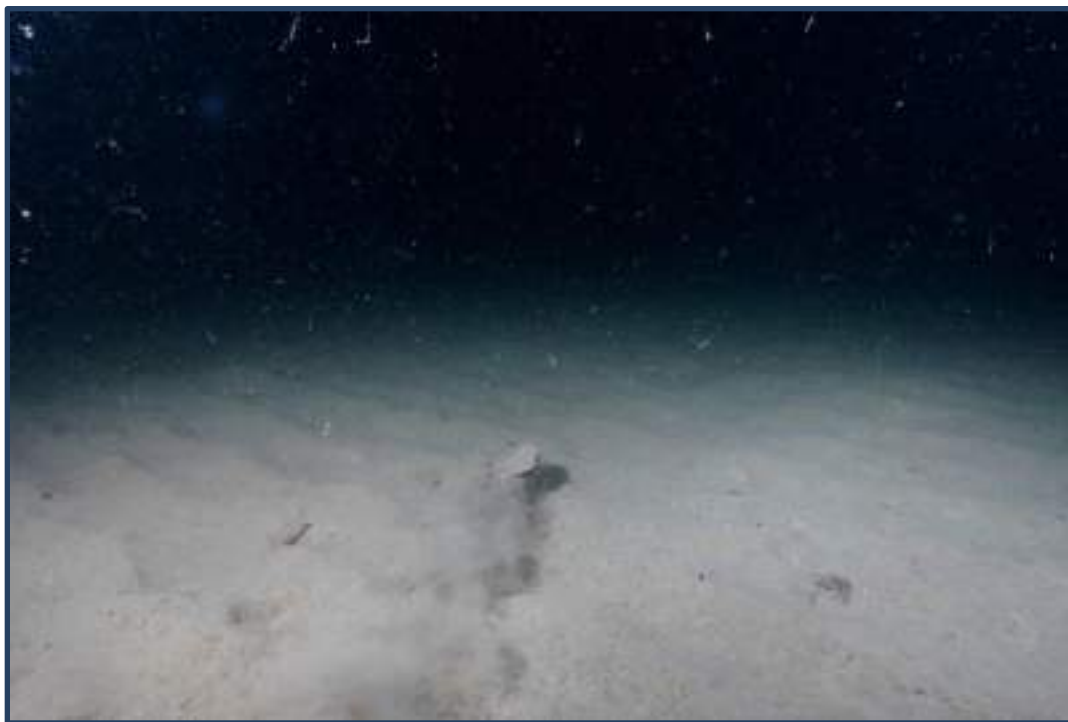
**Plate 3-11 Swimming crab, Waterford Disposal site, 10<sup>th</sup> September 2020**

The seafloor at station 7 consisted of fine sand formed into small waves with old oyster shells scattered over its surface (Plate 3-10). Place (*P. platessa*) (Plate 3-10), swimming crab (*Liocarcinus depurator*) (Plate 3-11), and edible crab (*Cancer pagurus*) (Plate 3-12) were all imaged at this location. A large shoal of juvenile horse mackerel (*Trachurus trachurus*) were also recorded (Plate 3-13).

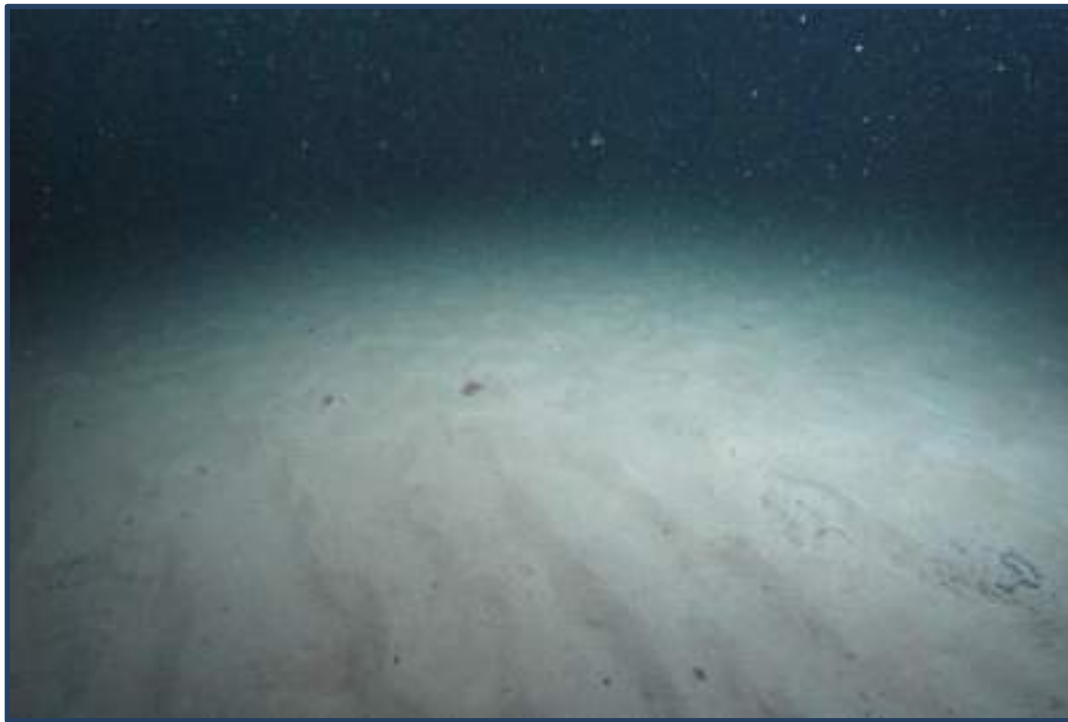
**Plate 3-14 Station 8, Waterford Disposal site, 10<sup>th</sup> September 2020**

The seafloor at Station 8 was composed of fine sand formed into small waves. A number of casts resulting from the burrowing activity of polychaetes (*A. marina*) were present on the surface (Plate 3-14).

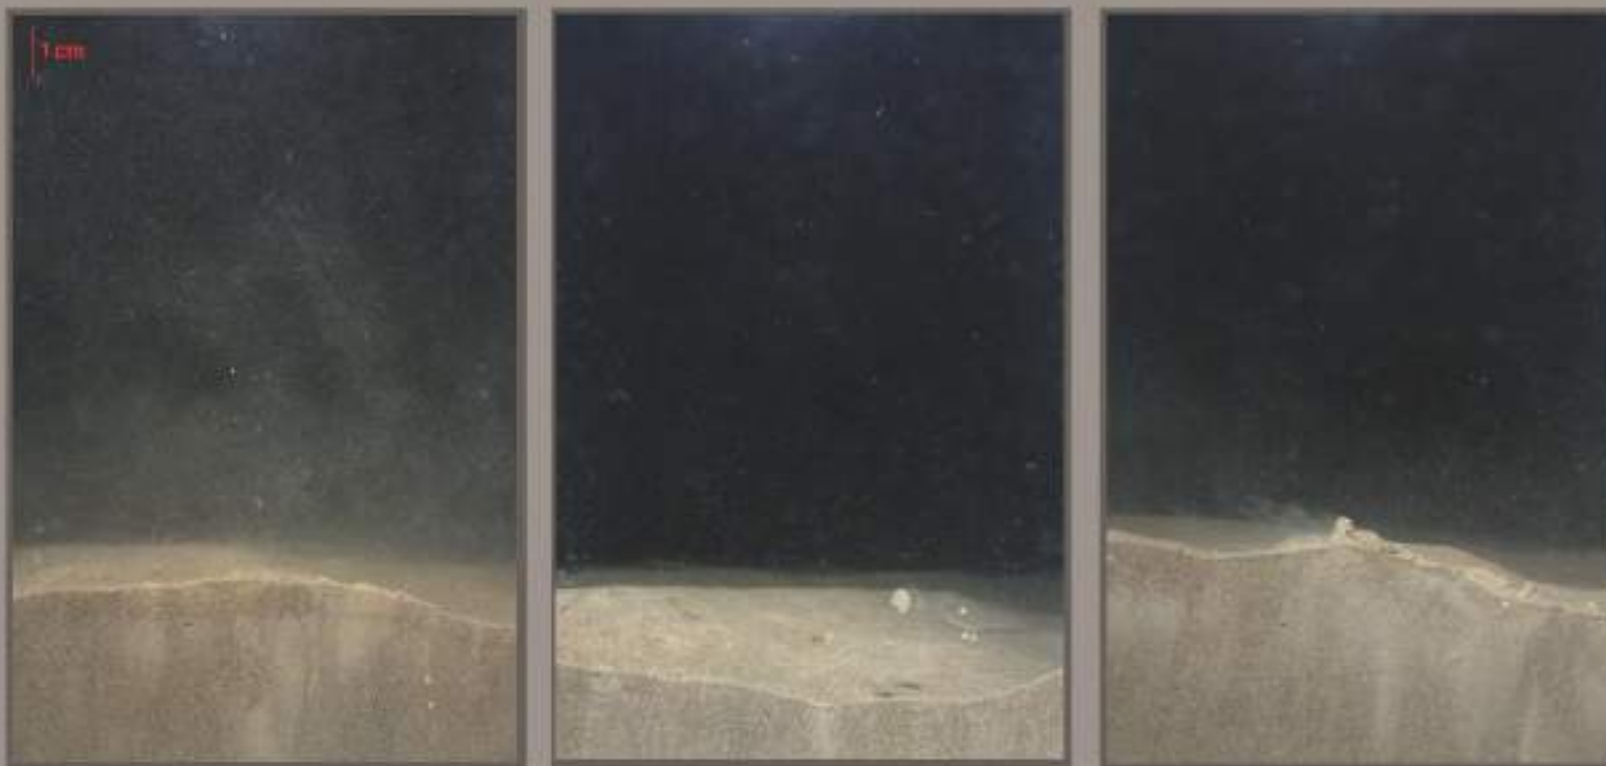
## Station 1

No infauna were observed in the images and given the disposal history of the site, all stations can be allocated a Stage I status, indicating recent disturbance.
