# **Survey of Benthic Habitats at the Port of Cork Licensed Dumpsite off Power Head including notes on Fisheries and an Impact Hypothesis**

**(June 2020)**

**Commissioned by:** Port of Cork Company  
**Carried out by:** Aquatic Services Unit  
**(December 2020)**

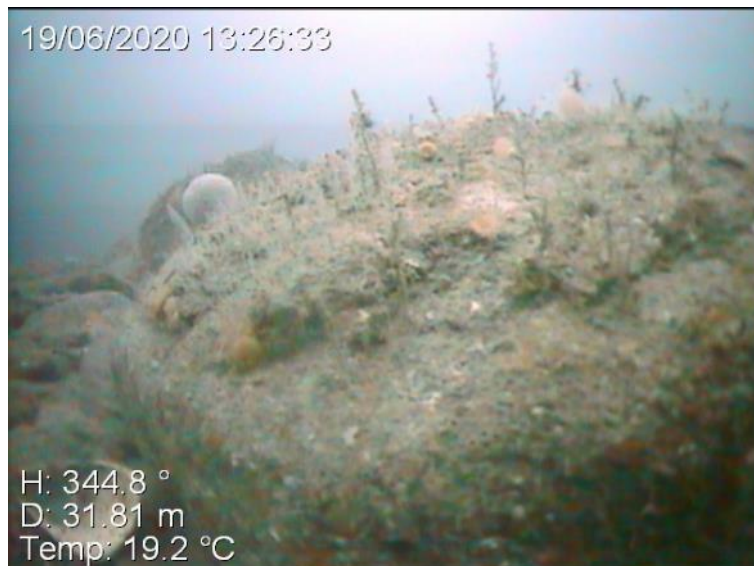
**Plate 03:** Boulder with Hydrozoa, bryozoans and *E. esculentus* at Drop V02.

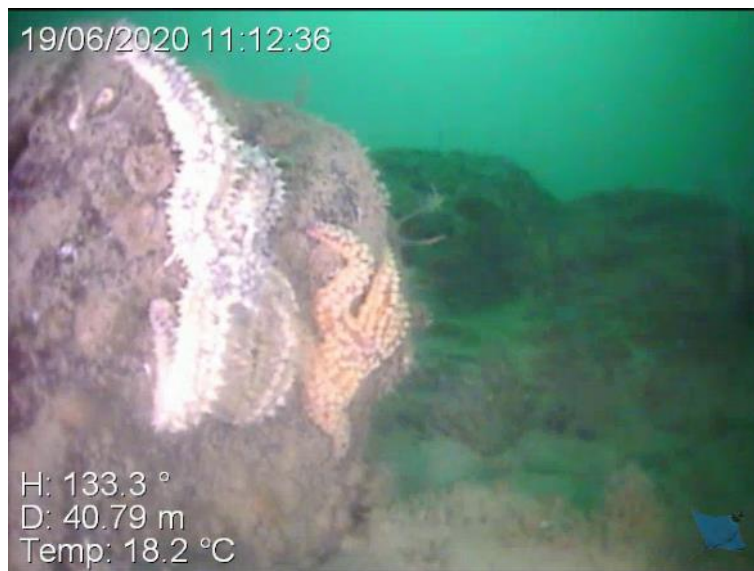
This site consists of bedrock with muddy sand present. The video shows a high degree of turbidity which reduces visibility at the site, but large areas of the seabed were seen. Visible fauna present at the site include Hydrozoa, *Serpulidae* spp., bryozoans, the Devonshire Cup Coral (*Caryophyllia smithii*) and the echinoderms *A. rubens* and *Marthasterias glacialis* (Spiny Starfish). The site has been classified as Echinoderms and crustose communities (CR.MCR.EcCr).

**Plate 05:** Spiny Starfish (*Marthasterias glacialis*) and Common Starfish, *A. rubens* and on bedrock at Drop V04.

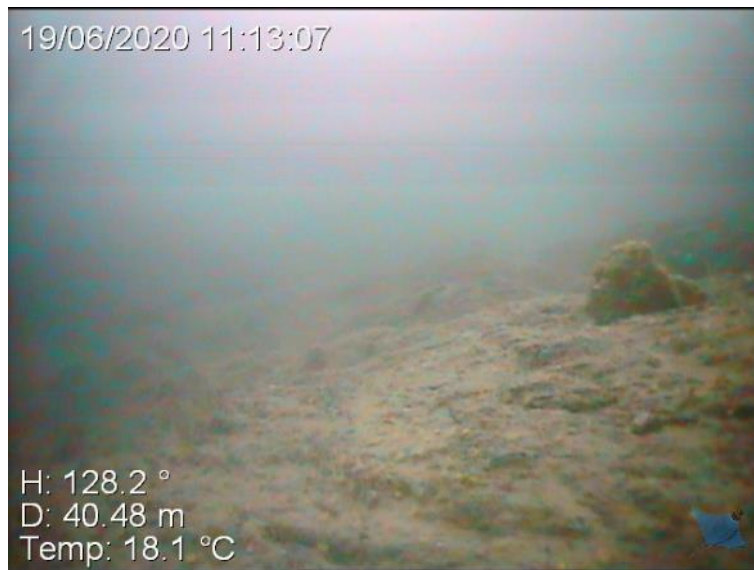
**Plate 06:** A thin veneer of sediment present on bedrock at Drop V04.

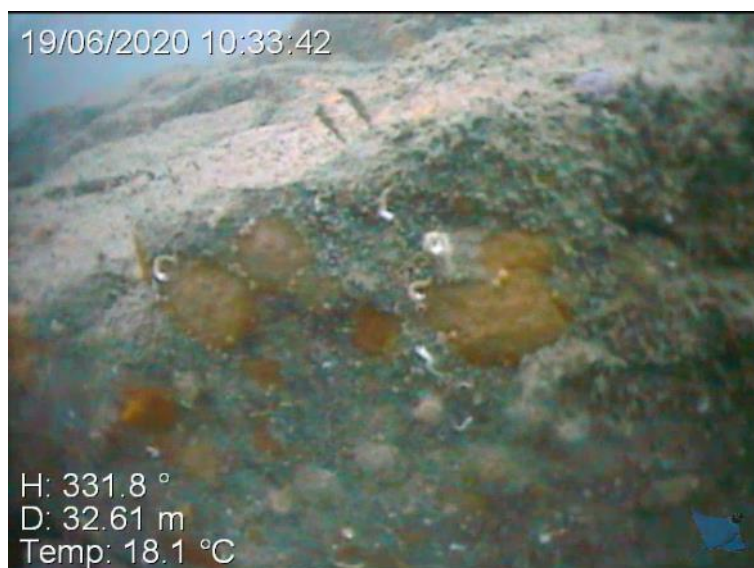
The site consists of muddy sands with cobble, with sparse epifauna present within this sand/cobble matrix. Areas of exposed bedrock which are common within the sediment matrix contain epifauna similar to those found in previous video drops, dominated by orange and blue sponge, hydrozoa, bryozoans, *Serpulidae* spp. and barnacles (*Thoracica*). Other fauna present on the bedrock include the echinoderms *Luidia ciliaris* [Seven-Armed Starfish], *A. rubens* and *E. esculentus*. Anthropogenic metal debris (a metal block) was present in the area. The site has been classified as 'Faunal and algal crusts on exposed to moderately wave-exposed circalittoral rock' (CR.MCR.EcCr.FaAlCr) leading to 'Sublittoral Mixed Sediment' (SS.SMx).

**Plate 07:** *Serpulidae* worms and patches of orange sponge present on bedrock and cobble from Drop V05

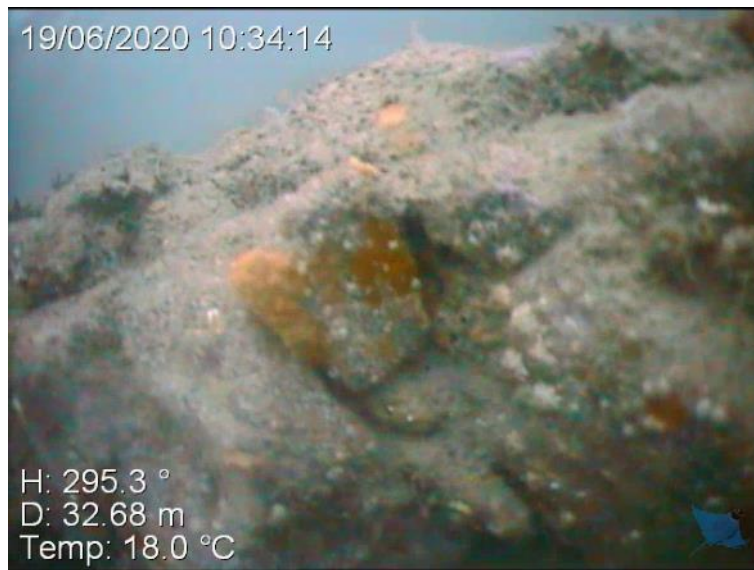
**Plate 08:** Barnacles (*Thoracica*) and orange sponge at Drop V05.

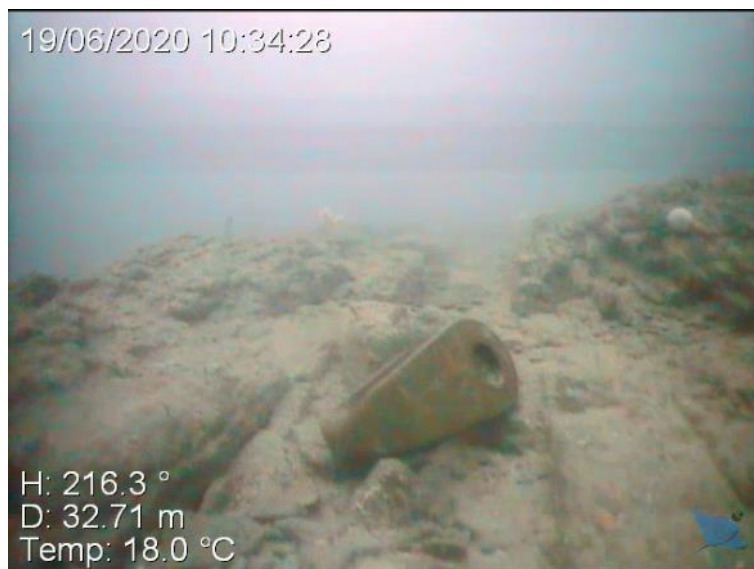
**Plate 09:** Muddy sand, with cobbles and boulders present at Drop V05. There was anthropogenic debris present at the site (large metal block).

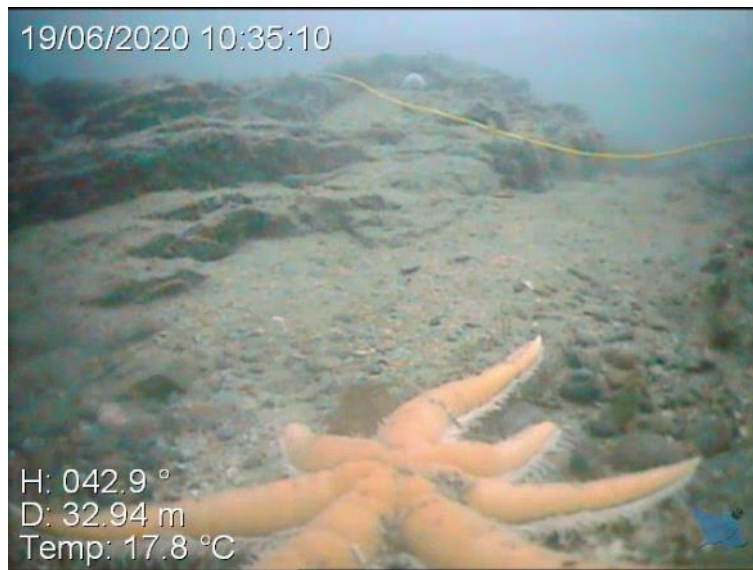
**Plate 10:** The seven-armed starfish, *Luidia ciliaris*, on sublittoral mixed sediment at Drop V05.

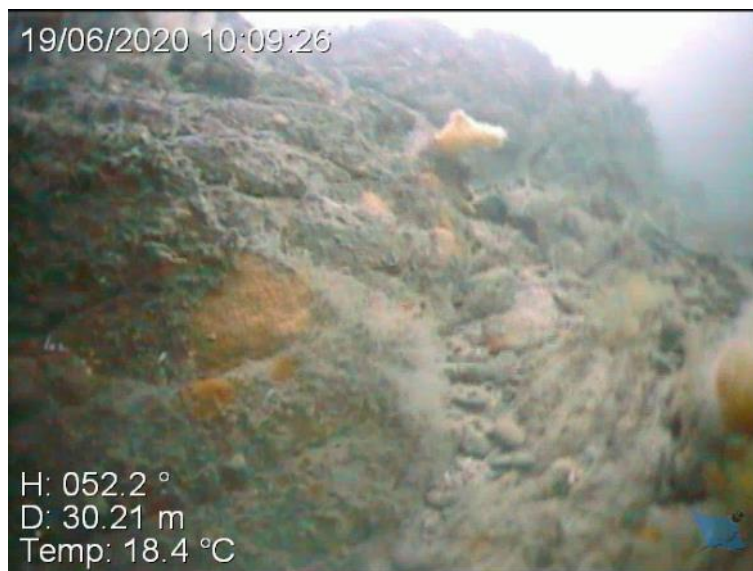
This area consists of bedrock with a surface layer of mud and/or sand. The cup coral (*C. smithii*), as well as the starfish *A. rubens* and *Henricia* sp. (either *H. sanguinolenta* or *H. oculata*) are present on the bedrock, as well as hydroids, *Alcyonium digitatum* [Dead-Man's Fingers], sponges and *Serpulidae* spp. Between the bedrock ridges are areas of sandy gravels with sparse visible fauna in these areas. The site has been classified as 'Faunal and algal crusts on exposed to moderately wave-exposed circalittoral rock' (CR.MCR.EcCr.FaAlCr).

**Plate 11:** Bedrock with epifauna at Drop V06 with *A. digitatum* present.

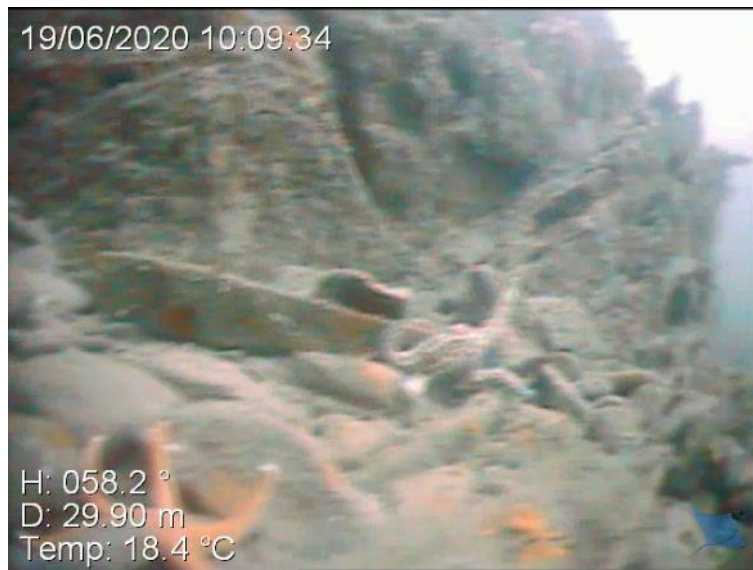
**Plate 12:** *Henricia* sp. and *A. rubens* present at Drop V06.

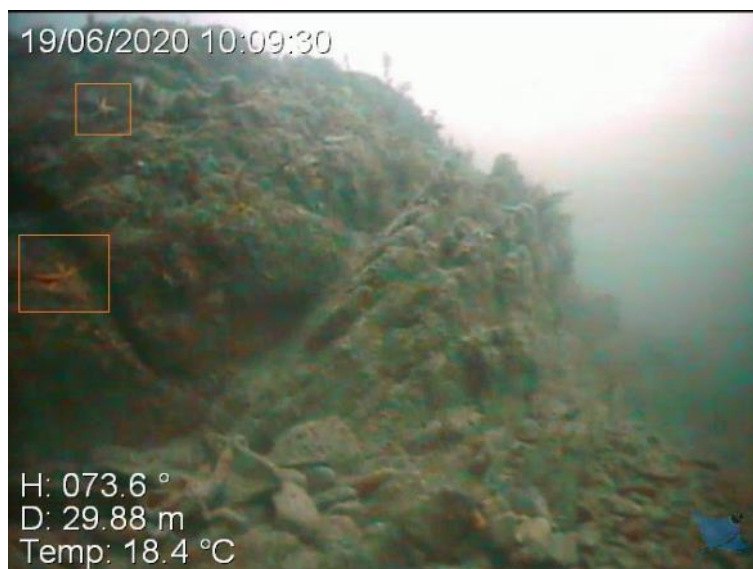
**Plate 13:** Starfish (orange boxes) and epifauna present on bedrock and cobble, which is typical for the area at Drop V06.

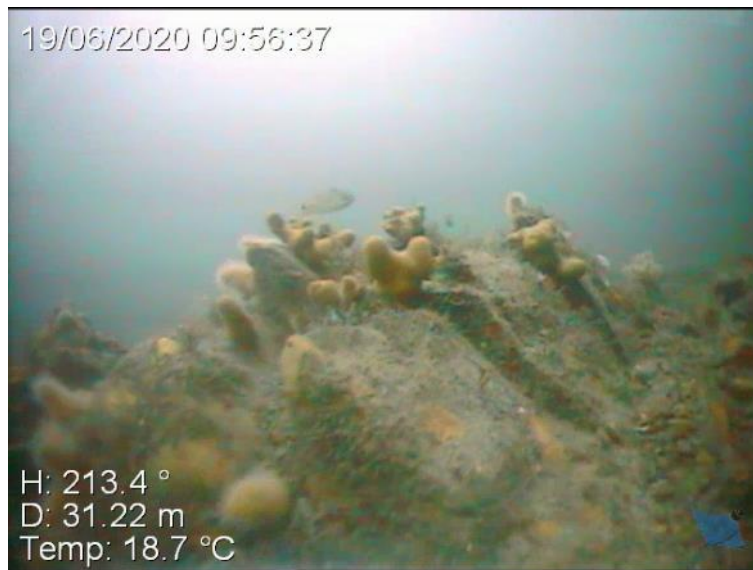
This site consists of mixed sediment with cobbles and boulders with occasional patches of visible bedrock. A number of epibenthic species were identified across the site including *A. digitatum*, Hydrozoans, *A. rubens*, *E. esculentus*. In addition, sponges and Bryozoa were present across the site as well as the tube building polychaetes, *Serpulidae* spp. There was no evidence of sediment build up at this site. Occasional pelagic fish (*Ctenolabrus repestus* [Goldsinny Wrasse] and *L. mixtus* [Cuckoo Wrasse]) were also identified at the site. The site has been classified as 'Faunal and algal crusts on exposed to moderately wave-exposed circalittoral rock' (CR.MCR.EcCr.FaAlCr).

**Plate 14:** A colony of Deadmans fingers (*Alcyonium digitatum*) on rock with Goldsinny Wrasse (*Ctenolabrus rupestris*) in the background at Drop V07

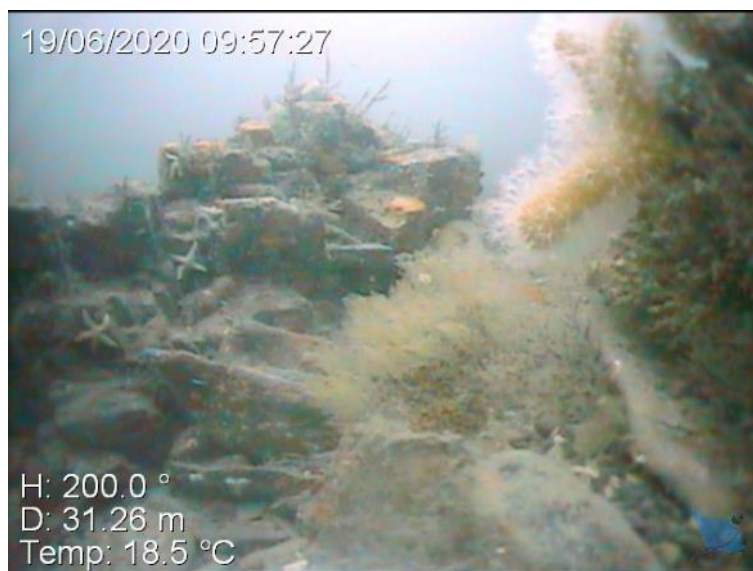
**Plate 15:** The soft-coral, *A. digitatum*, Hydrozoa, bryozoans, sponges and starfish (*A. rubens*) on bedrock at Drop V07.

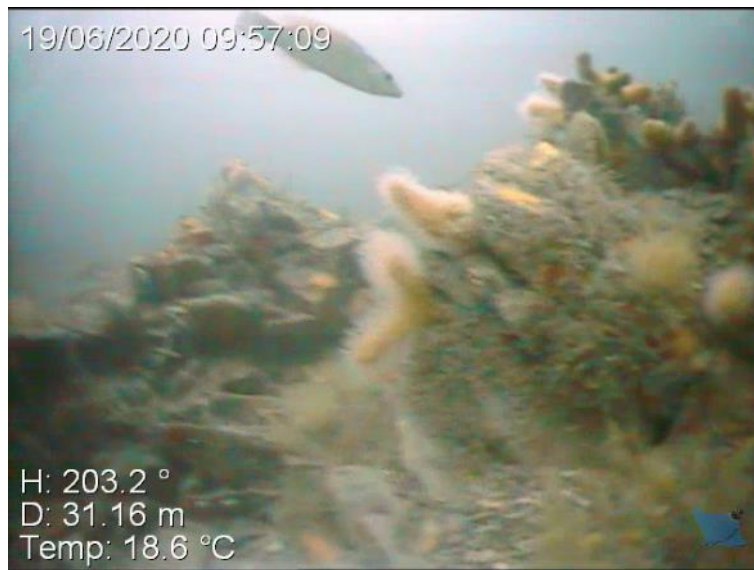
**Plate 16:** Cuckoo Wrasse (*L. mixtus*) swimming above bedrock with *A. digitatum* at Drop V07

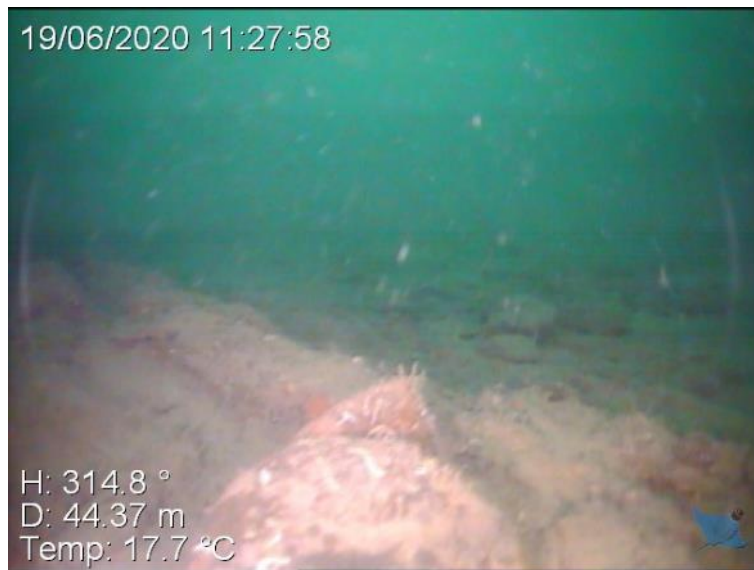
**Plate 18:** Hydrozoa and *Serpulidae* worms on cobble and boulder at Drop V08.

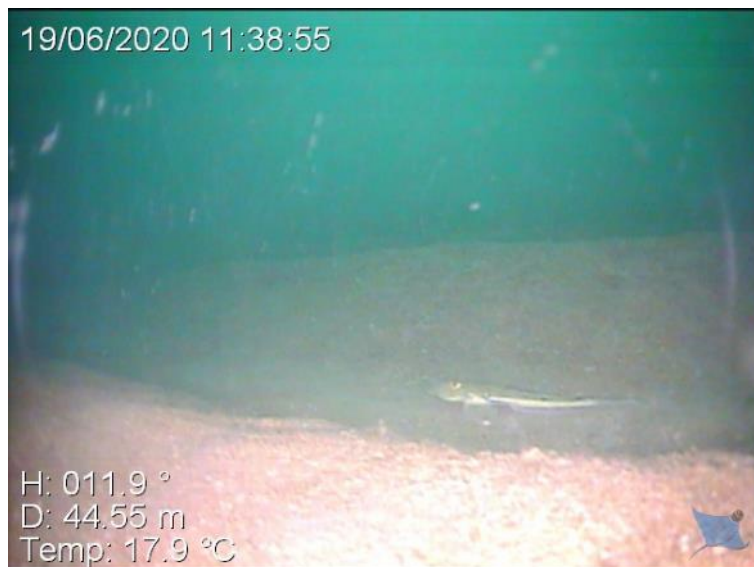
This site consisted of rippled muddy sands with occasional brittlestar (*Ophiura* sp.) and dragonet (*Callionymus lyra*) present at the site. The site has been classified as Sublittoral sands and muddy sands (SS.SSa).

**Plate 19:** Rippled muddy sands with the Dragonet (*Callionymus lyra*) on the sediment surface at Drop V09.

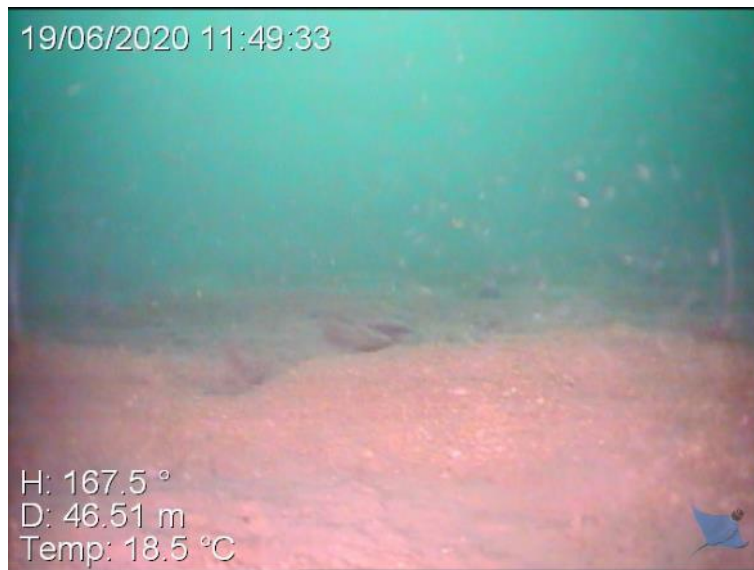
This site consists of rippled muddy sands and is similar to that identified at V09. No fauna was visible during the survey, but surface patterns indicate that burrowing fauna is present at the site. The site has been classified as Sublittoral sands and muddy sands (SS.SSa).

**Plate 20:** Rippled muddy sands at Drop V10.

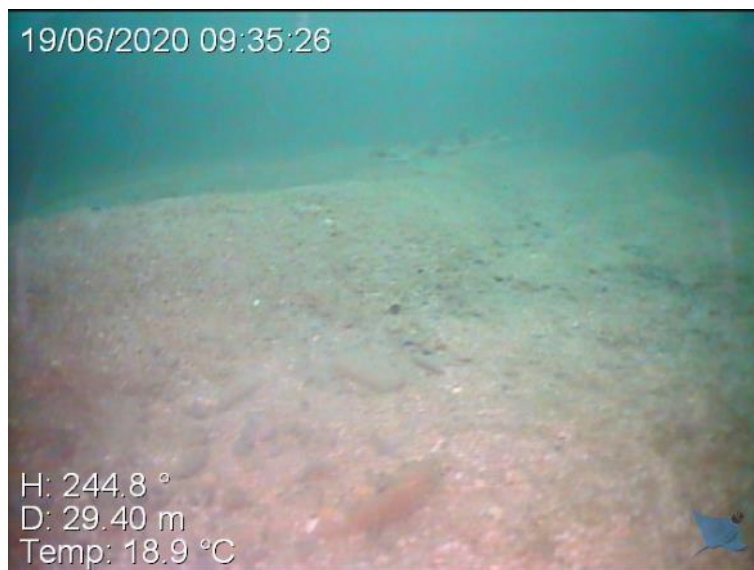
This site consists of rippled gravelly muddy sands. There was no obvious epifauna present on the seabed at the site, fish were identified at the site with dogfish (possibly *Scyliorhinus canicula* [Lesser-spotted dogfish]) identified swimming above the seabed. The site has been classified as 'Sublittoral Mixed Sediment' (SS.SMx).

**Plate 21:** Lesser spotted dogfish (*Scyliorhinus canicula*) in the background swimming over rippled sands at Drop 11

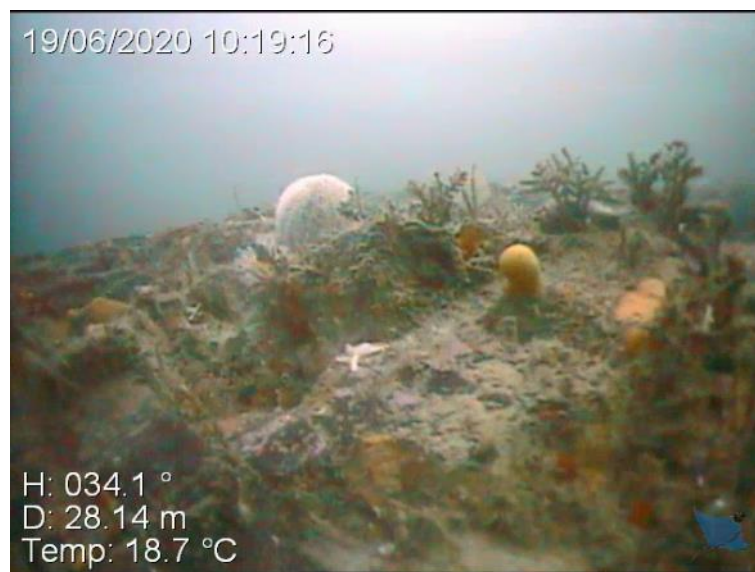
**Plate 23:** Epifauna including arborescent brown sponge and *E. esculentus* on bedrock at Drop V12.

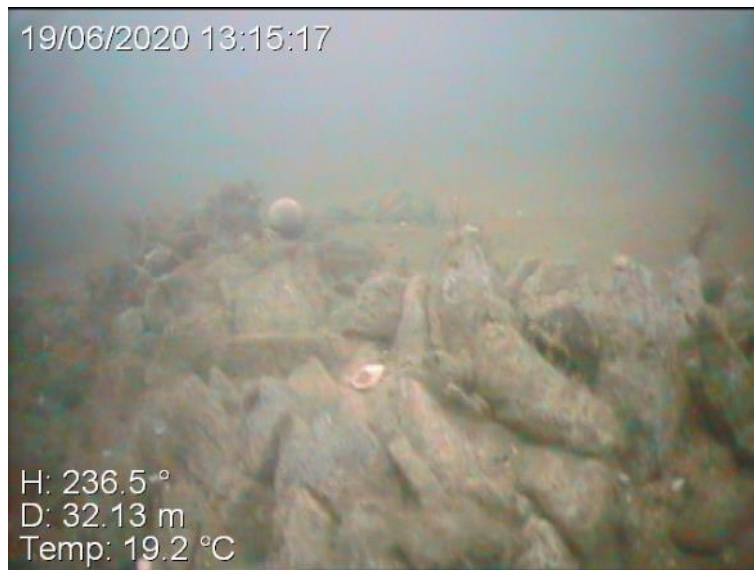
This site consisted of exposed bedrock and mixed sediment with incidental patches of boulders in rippled gravelly sands. In areas of exposed bedrock hydrozoa, bryozoans, sponges and *Serpulidae* worms were evident, in addition to the echinoderms *E. esculentus* and *A. rubens*. The site has been classified as a mosaic of Sublittoral Mixed Sediment (SS.SMx) and Echinoderms and crustose communities (CR.MCR.EcCr).

**Plate 24:** Echinoderms *E. esculentus* and *A. rubens* on bedrock with sand surrounding the bedrock at Drop V13.

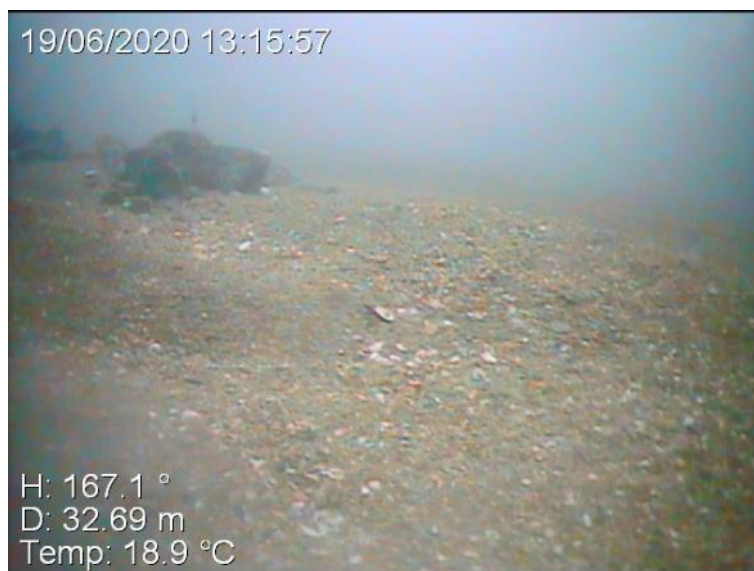
**Plate 25:** Coarse sands and mixed sediment sat Drop V13.

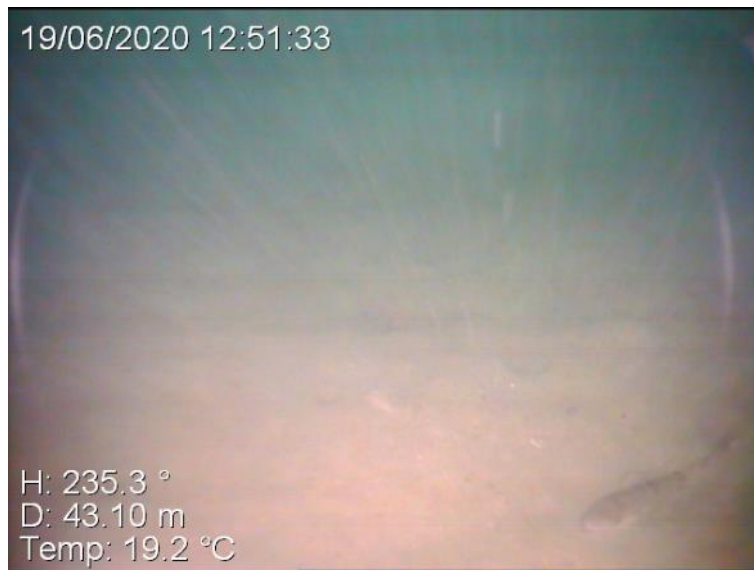
This site is dominated by muddy sands across the site. No fauna was visible on the sediment surface but there was evidence of burrowing fauna present at the site. A dragonet (*C. lyra*) was seen on the sediment surface at this site. The site has been classified as Sublittoral cohesive mud and sandy mud communities (SS.SMu.CSaMu).

**Plate 28:** The dragonet on sandy muds from Drop V16.
