Ringaskiddy Basin and Berths, Port of Cork
Navigation Maintenance Dredging, 2023-2030

Underwater Archaeological Impact Assessment

August 2023

Port of Cork

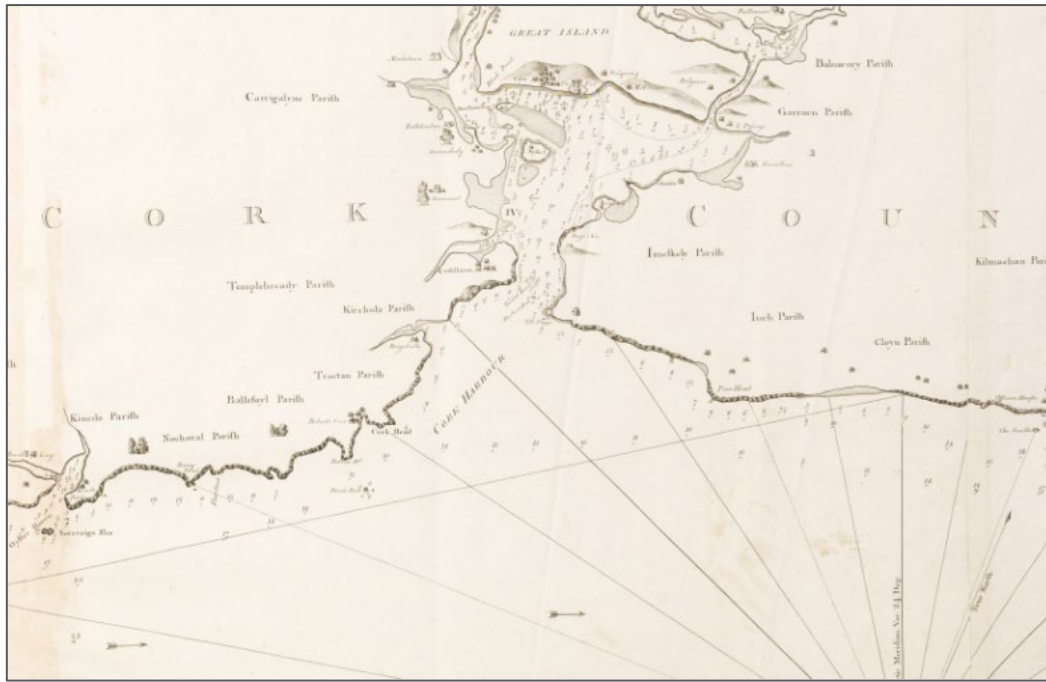
Figure 3: Extract from a 'The South Coast of Ireland from Cable Island to Gally Head' (Mackenzie, 1775).

A survey carried out by Murdoch Mackenzie in 1775 charted the coast of Ireland, including the proposed disposal site and dredge sites (Figure 3). This survey shows a large house at 'Ballybricken' and a small settlement at 'Grinaskedy'. It does not show any improvements along the foreshore. This map does not record any features within the proposed disposal site.

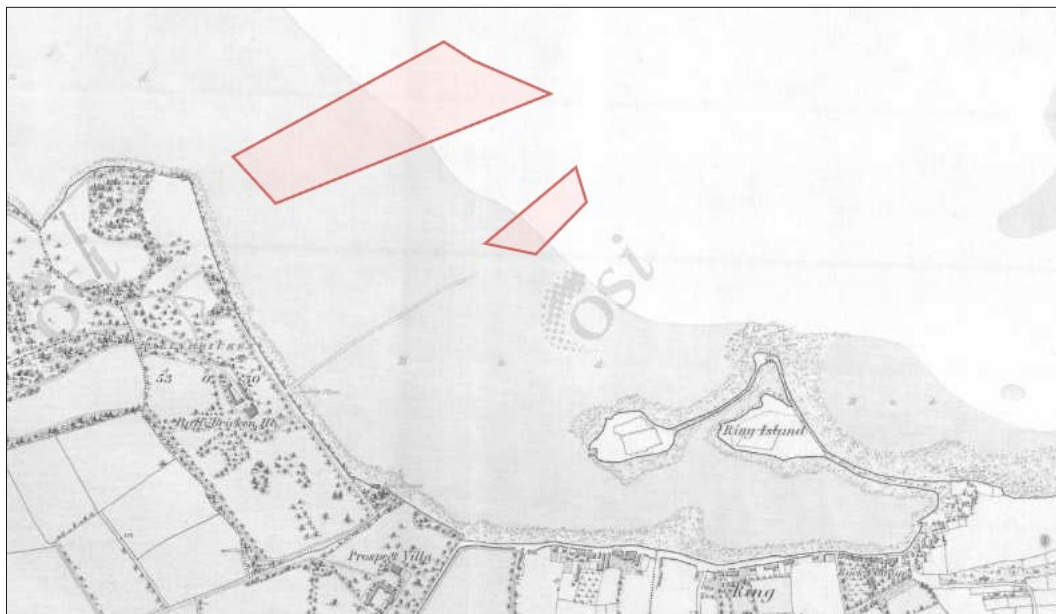
Figure 4: Extract from OS 6-inch map (1841-2), showing the general proposed dredge locations.

The OS 6-inch map (1841-2) (Figure 4) shows a landing place extending out from the foreshore adjacent to Ballybricken House. This landing place extends almost to the southwestern limit of the proposed southeast dredge pocket. The footprint of the proposed northwest dredge pocket does not contain any features. Much of the reclaimed land that now makes up Ringaskiddy Port was not yet in existence, and 'Ring Island' is clearly shown to the southeast, with causeways connecting it to the mainland.

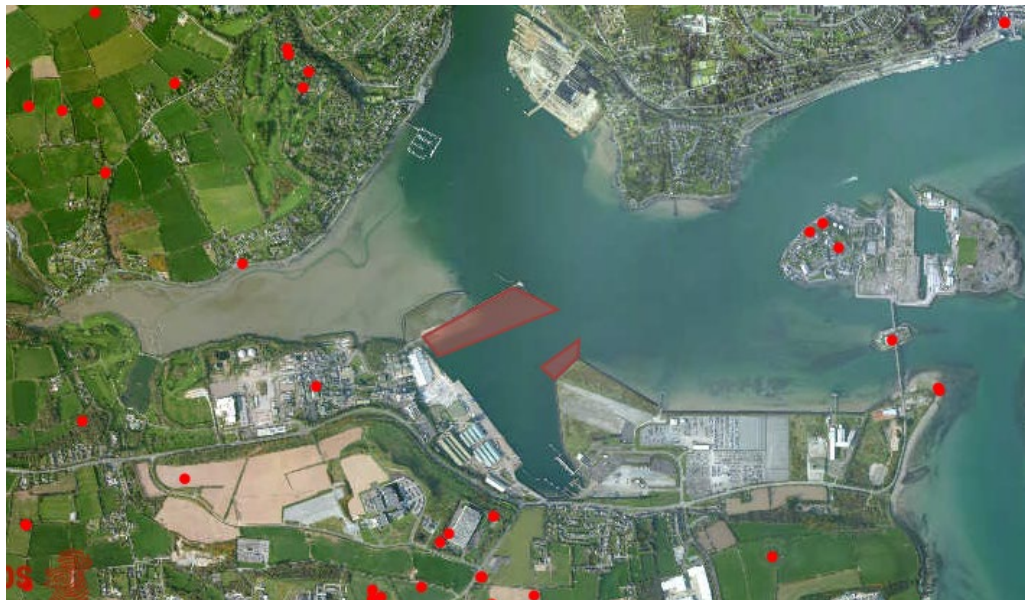
Figure 6: Locations of RMPs and SMRs surrounding proposed dredge pockets.

There are no SMR/RMP listings within the proposed dredge pockets. There are six listings within a 1km radius (Appendix 9.3). The closest of these was an ecclesiastical site, located c. 550m to the west of the proposed northwest dredge pocket, which was recorded to date back to c. 1100 AD, although it now lies in an industrial complex with no surface traces recorded.
