**Buncrana Harbour**  
**Dumping at Sea Permit S0011-03**  
Annual Environmental Report 2018

ISSUE FORM	
Project number	18670
Document revision	A
Document title	Annual Environmental Report
Document status	Final
Document prepared by	SR (MWP 2019-03-29)
Document checked by	MK (MWP 2019-03-29)

Donegal County Council (DCC) was granted a Dumping at Sea (DaS) Permit (Reg. No. S0011-03) by the EPA in July 2018. The Permits allow for maintenance dredging at Bunrana Harbour of up to 8,000 tonnes of material each year for eight years up to a maximum of 64,000 tonnes in total and subsequent disposal at sea by plough dredging.

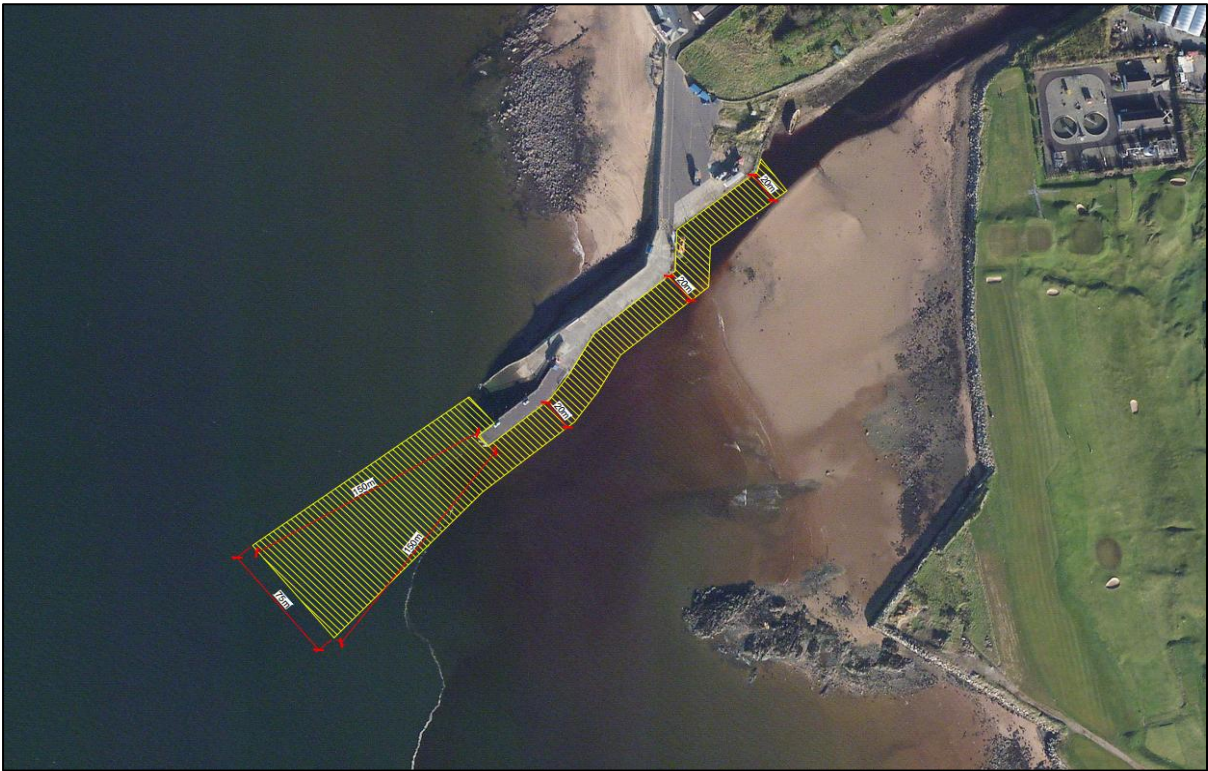
Figure 1 – Loading/Dredging Area

The dredge/loading area and the disposal/dumping area are shown in **Figure 1** and **Figure 2**. The dredge area is approximately 1.45 ha, comprising the approach channel to the pier and slipway and the main berths at the pier. The dumping area is approximately 27.45ha, comprising the area surrounding the pier and slipway extending northwest, due west and southwest.

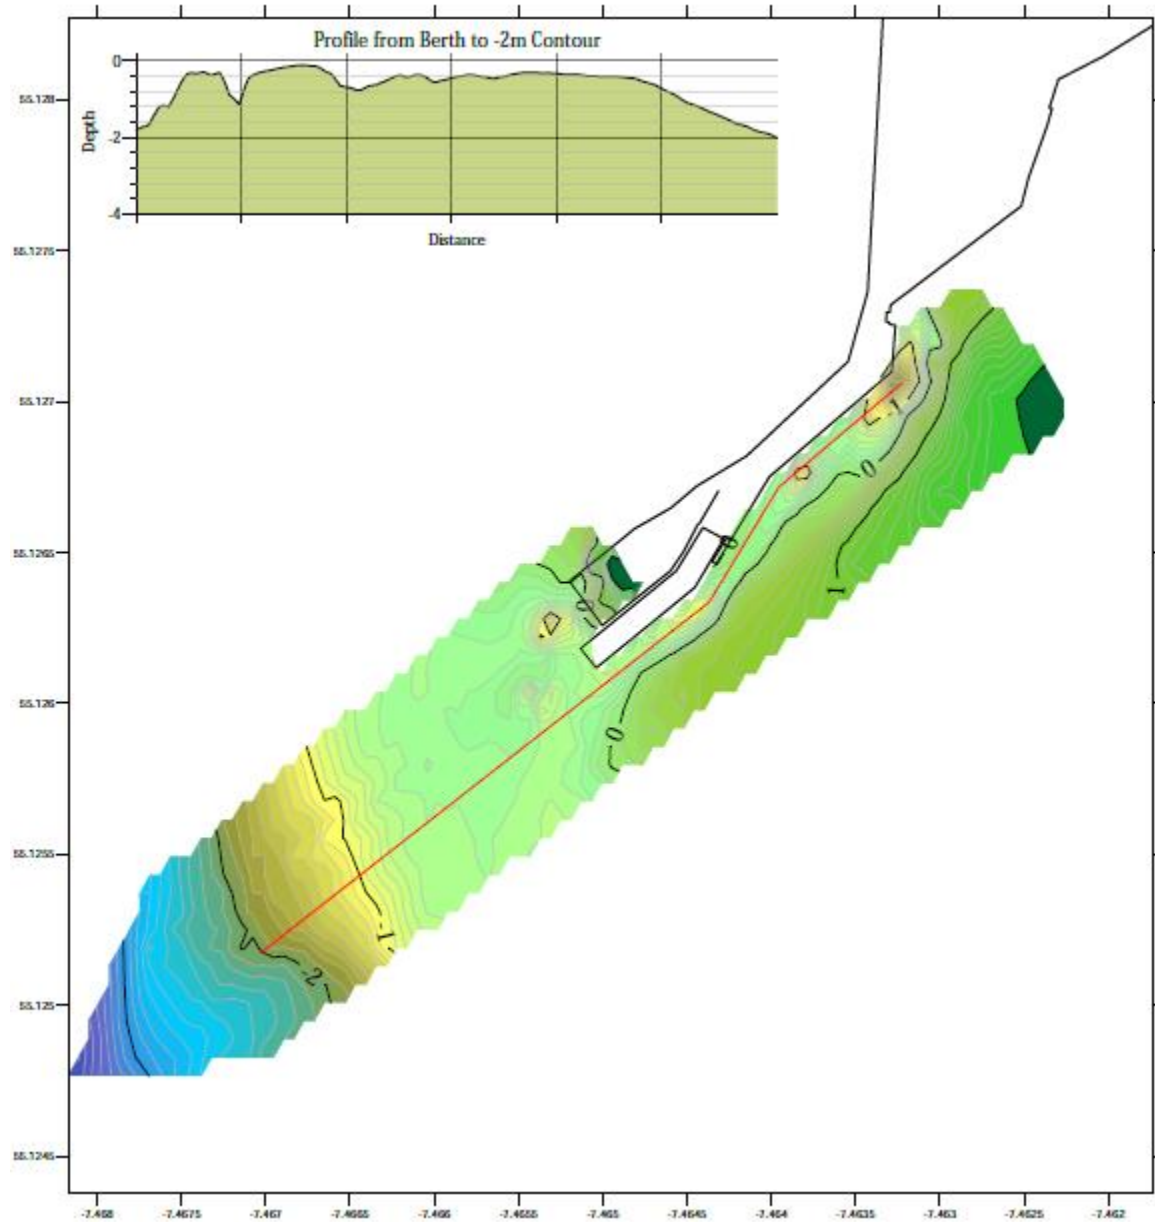
## Survey of 19<sup>th</sup> July 2018

Data was taken on 19<sup>th</sup> July prior to the commencement of dredging. At the lifeboat berth, the water jets have caused an excavation to -2m where the life boat manoeuvres. A similar anomaly can be seen alongside the pier where the ferry moors and off the slip, due to the ferry holding station. These are all normal and expected. The channel is very shallow close to the berth and less than -0.4m over almost 200m.

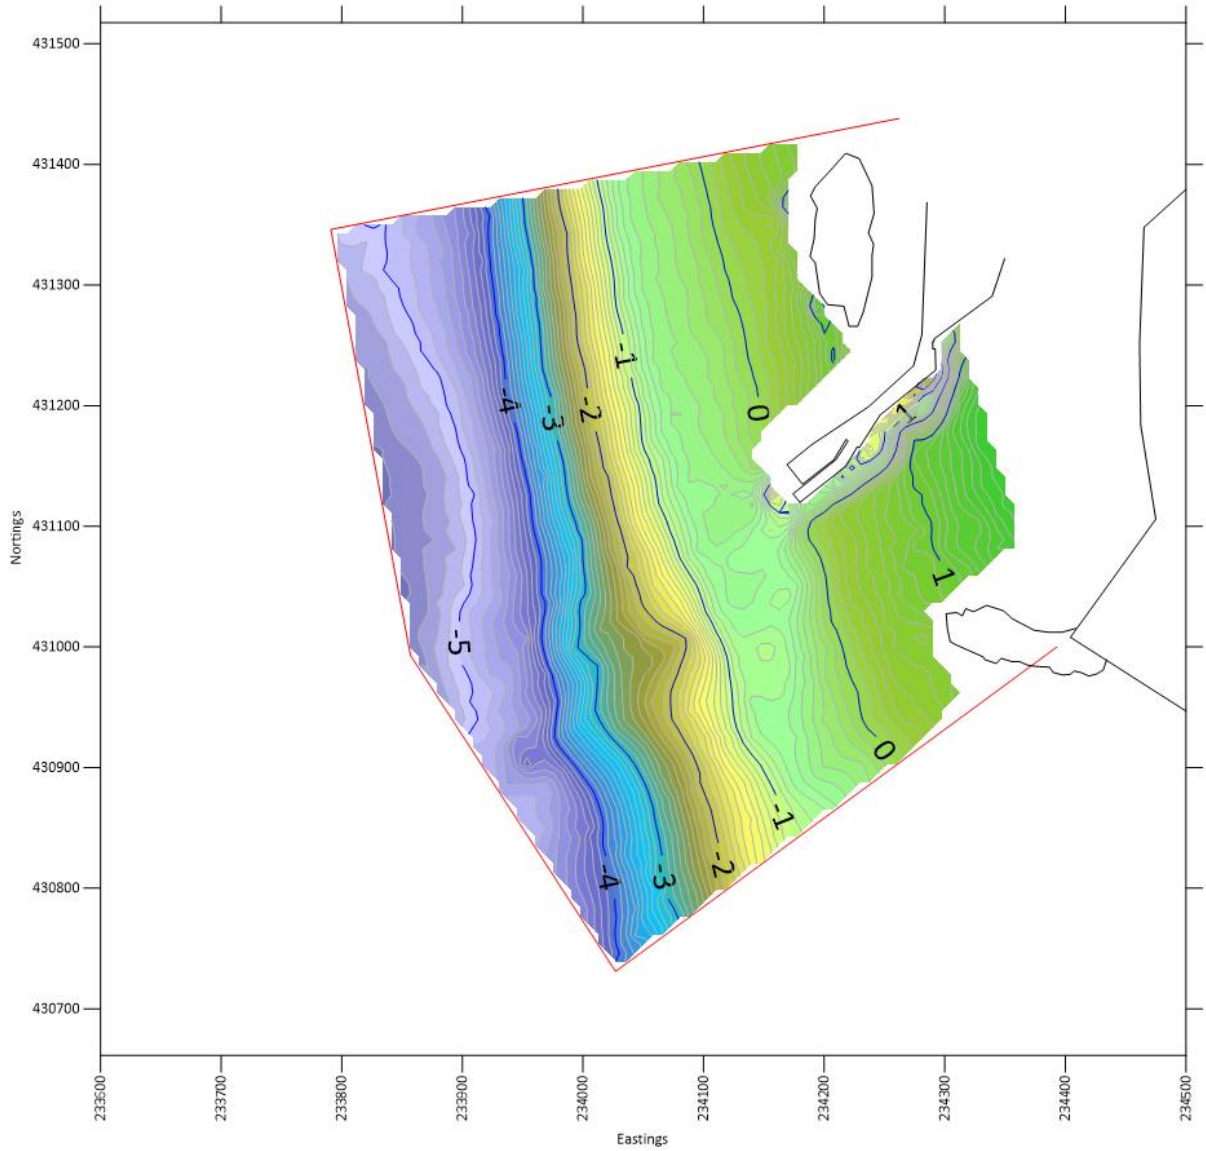
Figure 3. Contour map of spoil area, 9<sup>th</sup> August 2018

For clarity, the minor contour lines have been removed and the 1m contours of the survey of 9<sup>th</sup> August (blue) have been overlaid on the contours of 19<sup>th</sup> July (black), any difference in the contours from 0m to -4m is negligible.

It is estimated that 1,243 m<sup>3</sup> of material was removed between 19<sup>th</sup> July and 9<sup>th</sup> August 2018; the overall area enclosed by the box is c. 275,000m<sup>2</sup>. If this volume of material was deposited evenly across this area is not measurable and will be indistinguishable from noise. There are no heaps of material or new anomalies. The only contour showing measurable difference is the -5m contour, with a difference of c. 20cm across several hundred meters. There is no ready explanation for this variation.

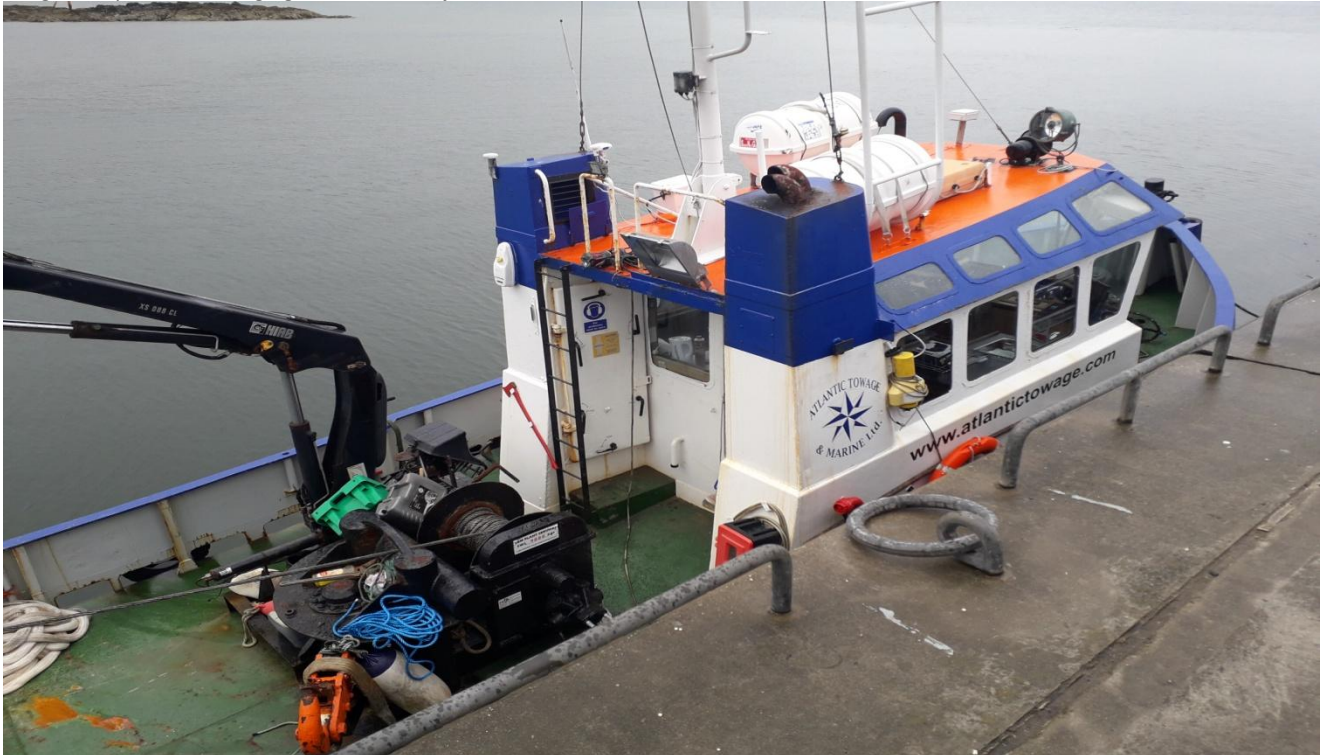
Photo 1  
Lough Swilly Marine Dredging Vessel, the Trojan

Maintenance dredging is to be carried out over an eight year period to allow safe access to the RNLI Lifeboat and other vessels that use Buncrana Harbour. An eight year dumping at sea permit was obtained to allow dredging and dumping of recently deposited material alongside Buncrana Harbour. The eight year dredging permit allows annual dredging to aid access to the Harbour. The permit will allow up to 64,000 tonnes of dredged material to be removed from the Pier vicinity and dumped at an appropriate location approximately 160m from the end of the pier.

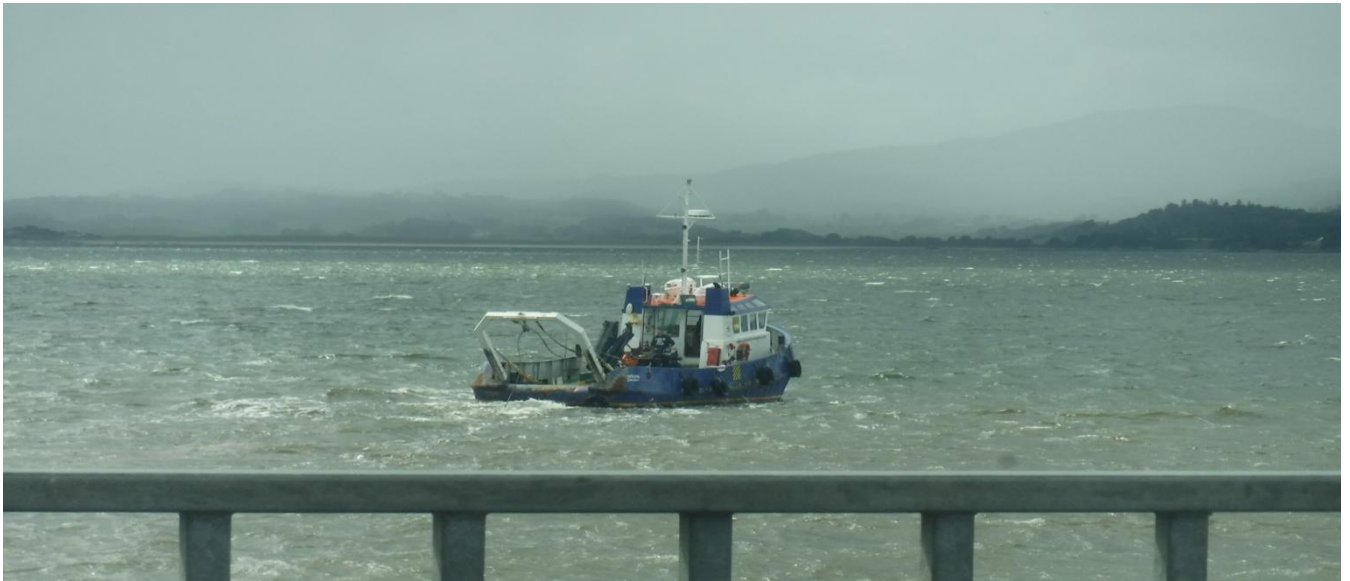
Photo 1  
Trojan making it way to the Dump Site:

The dump site, located approximately 160m from the end of the pier is a large deep channel with enough capacity to hold the dredged material. Lough Swilly has strong tidal currents that are associated with its relatively shallow sections and tide flow; this will aid dispersal of the dredged material evenly within the Lough Swilly area.

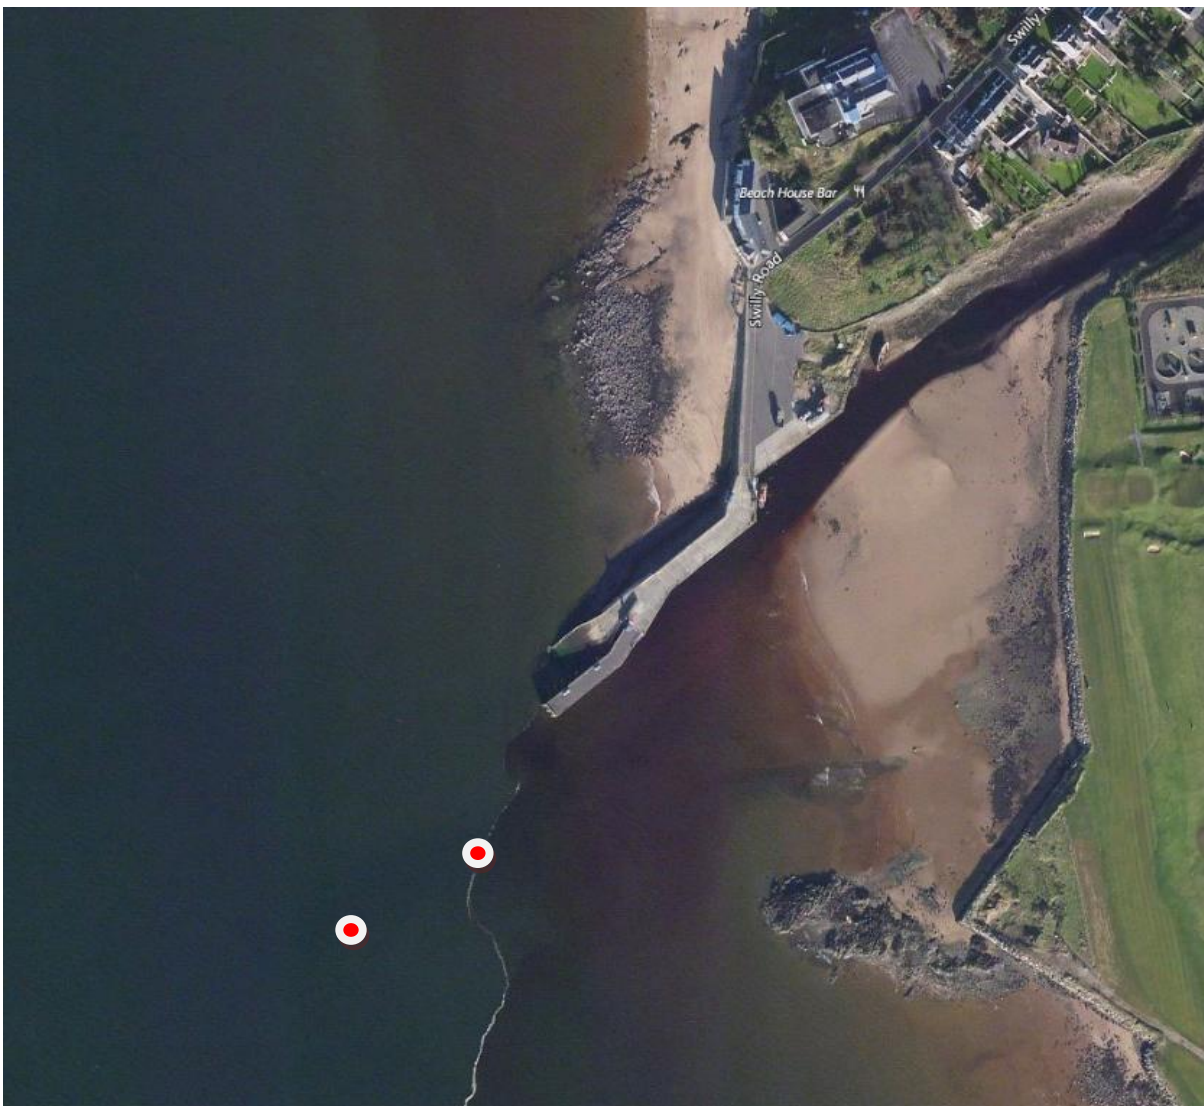
Figure 4 Locations of Marine Mammal Observations at Buncrana Harbour During On-going Dredging Works

During the survey period a total of 2 incidents on marine mammals were observed during a total of 248 hours of observation. All of the marine mammal sightings were of Common Seal. No marine mammals were detected during the start up process of each survey day, no delay to the dredging activity was required or mitigation measures imposed to works being carried out. Pre source activity was delay because of marine mammal observations prior to start up of operations.
