**Port of Waterford**  
**Navigation Maintenance Dredging Programme 2026-2033**  
**Underwater Archaeological Impact Assessment**

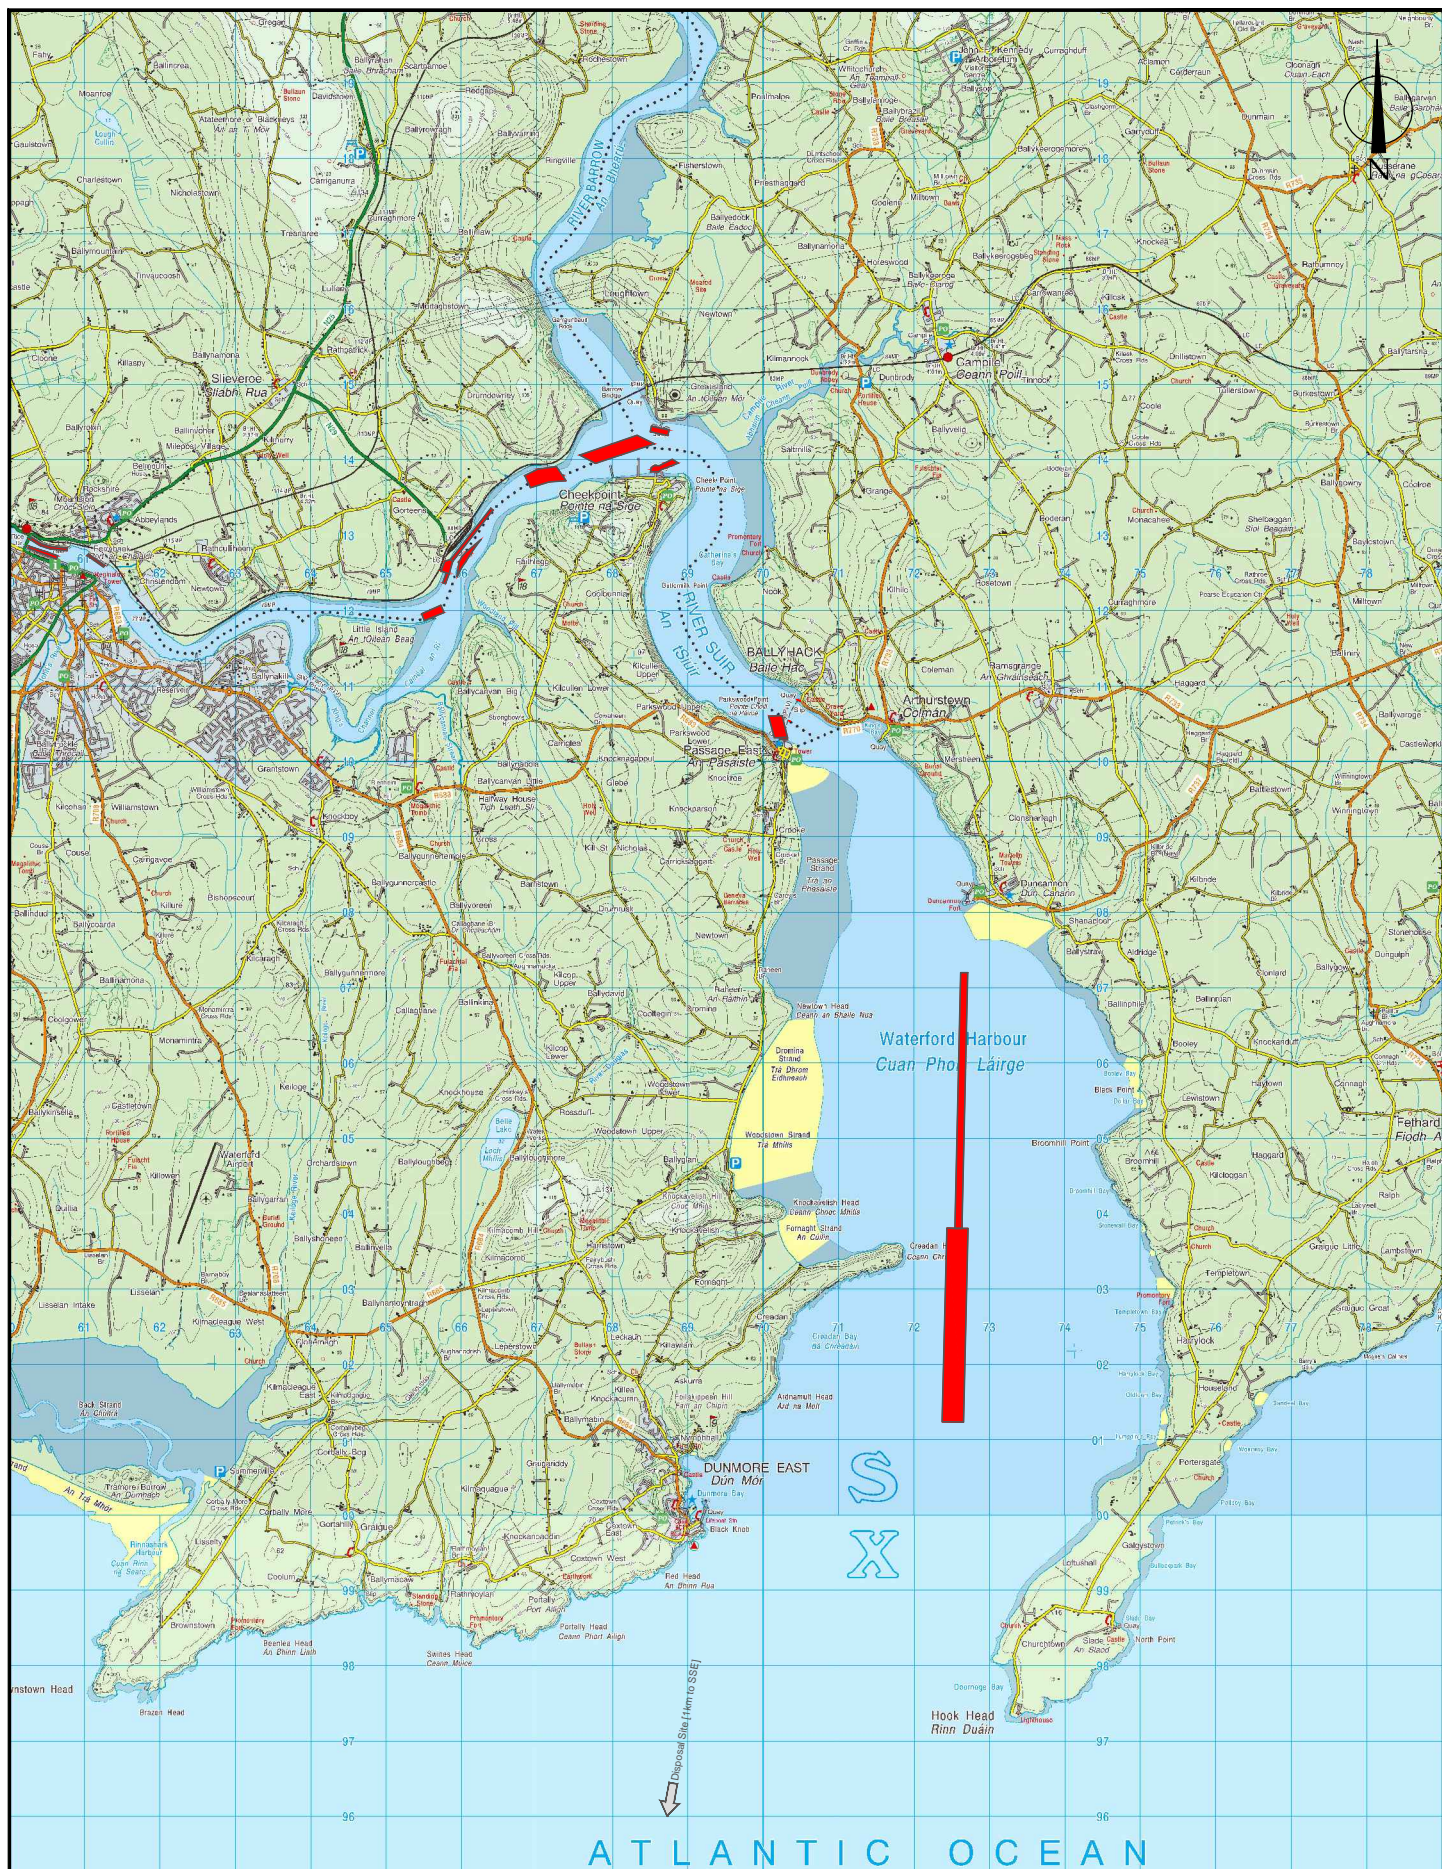
**Drawing No.**  
Figure 1

Source:  
Background Map- OS (1:50,000) Discovery Series Mapping- map tiles  
OS2608 and OS2610.  
Dredge Areas- extent taken from Project Drawing Proposed Dredge  
Areas 636\_consultation\_PreApp [REDACTED].

**Title**  
Figure 1- Location of proposed Dredge Areas under  
consultation as part of the Port of Waterford  
Maintenance Dredging.

Sixteen locations are regularly dredged by the Port of Waterford to maintain the ruling depth of the approach channel and quaysides, between Waterford city upstream and Creadan Bank in Waterford Harbour (Figure 1).
